WHY BUILDINGS FALL DOWN

How Structures Fail

MATTHYS LEVY
and
MARIO SALVADORI

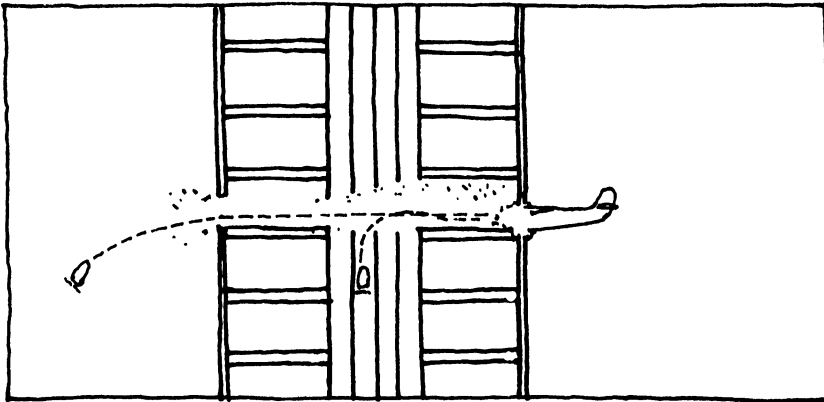
2.3b Impact and Path of Motors

plane, the wheels were lowered moments before the plane struck the Empire State Building on the north face of the seventy-ninth floor, 913 ft. (278 m) above the ground, ripping a hole 18 ft. (5.5 m) wide and 20 ft. (6 m) high in the outer wall of the building (Fig. 2.2). The force of the impact sheared off the wings of the plane and propelled one of the two motors across the width of the building, through the opposite wall, and down through the twelfth-story roof of a building across Thirty-third Street, starting a destructive fire that demolished the studio of Henry Hering, a noted sculptor of the time (Fig. 2.3). The other motor and part of the landing gear crashed into an elevator shaft and fell all the way down to the

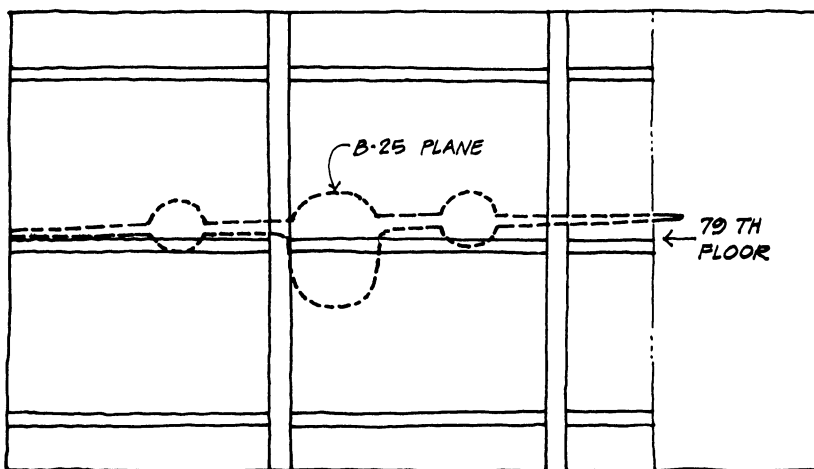
2.4 B-25 Straddling Column

The center of impact aligned almost exactly with a column on the face of the tower. The right motor passed on one side of the column and the left motor on the opposite side (Fig. 2.4). The column itself was barely damaged, although a steel beam supporting

the masonry wall struck by the right motor was torn out, and a second beam supporting the floor slab was bent back 18 in. (450 mm). The plane apparently struck the seventy-ninth floor dead-on, which explains the lack of damage to the column. Had the plane been just a bit higher or lower, it might have struck and bent the column, and then . . .

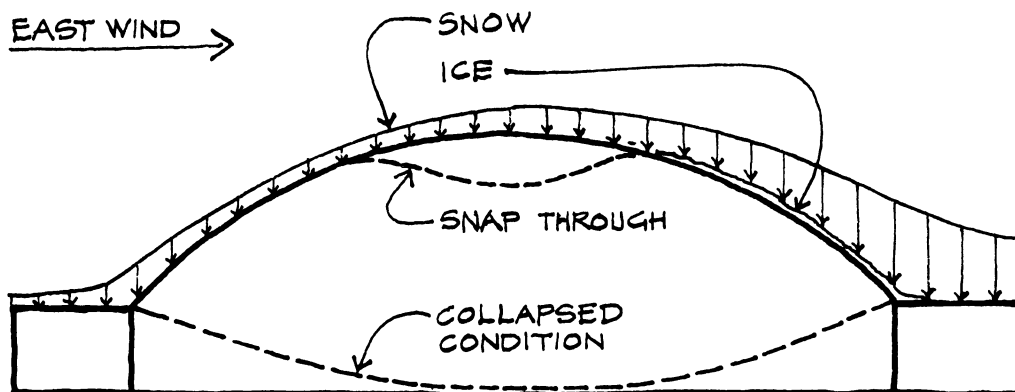
3.12 Stages of Collapse of C. W. Post Dome

Between 2:00 and 3:00 A.M. on Saturday, January 21, 1978, the center dome suddenly caved in under mounds of snow and ice. “It looks like a giant cracked eggshell,” commented Officer Stephen Chand of the Old Brookville Police Department (Fig. 3.12). Only four days earlier the 360 by 300 ft. (110 × 90 m) *flat* steel roof of the Hartford Civic Center Arena had collapsed under similar conditions (see p. 68), and one could have heard then the “amateur structuralists” comment on the traditional strength of the dome, the prototypical “form-resistant” structure: “They should have used a dome instead of a flat roof. It would have been stronger and cheaper!” But now . . . ?

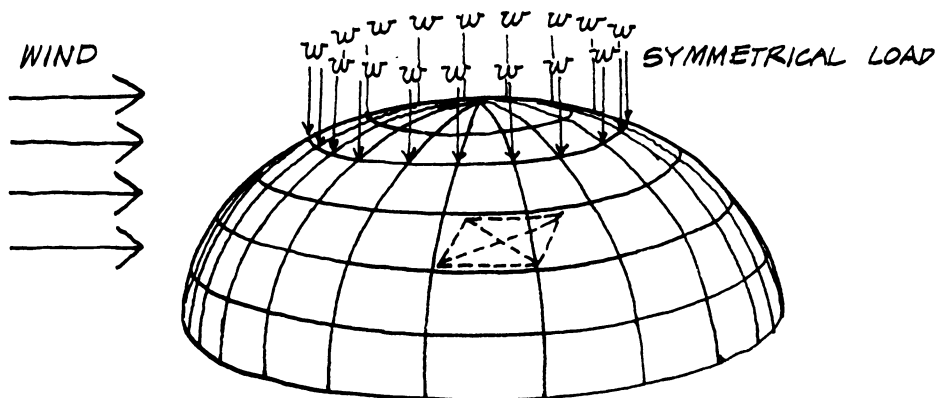
3.14 Skewing of Radial Ribs Caused by Wind

But perhaps the most dangerous consequence of using membrane theory in the design of shallow reticulated domes is that under symmetrical gravity loads its meshes *shrink* (slightly) on all four sides, *remaining square*, while under wind loads they become skewed (Fig. 3.14) and require diagonals to be stable. Finally, since most of the bars of the mesh are compressed, reticulated domes must be checked against the dangerous phenomenon of *instability in buckling as a whole*, which causes the dome to invert or *snap through*. (You may easily check instability in buckling by pushing down on a thin metal or plastic ruler that will bend out at right angles to its thin surface and lose all capacity to resist compression higher than a small push [p. 289, Fig. D4].) Rather unwisely the

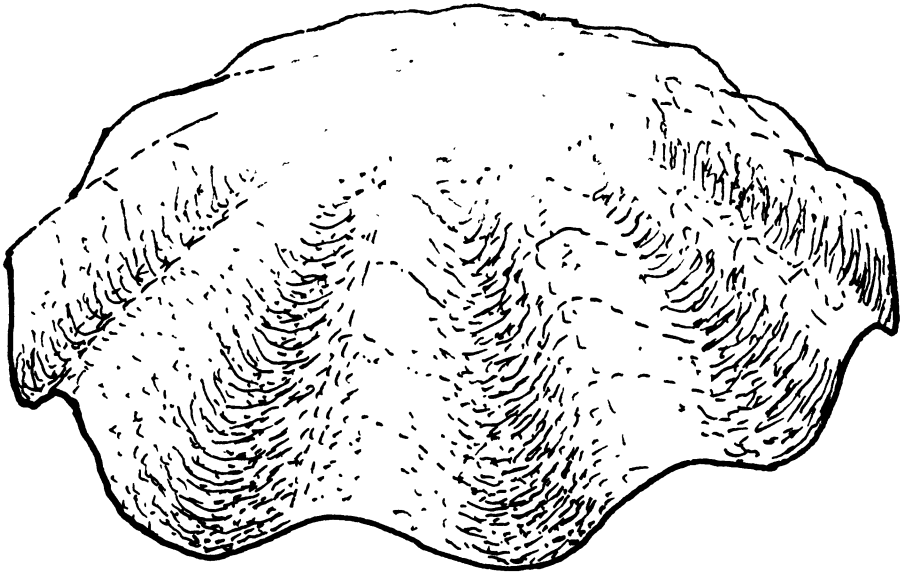
3.17 Local Radial Buckling of a Dome

Soare also remarked later that the bridle node connections had been entirely unable to prevent the relative sliding of the pipes meeting at the nodes. Rigid connections at the nodes of a reticulated dome are essential to maintain unchanged the geometry of the dome and to prevent bending deformations at the joints; no

light reticulated dome can be self-supporting without the satisfaction of these two conditions. Thus a probably minor saving in the cost of the connections may well have been a major contributory cause of the collapse.

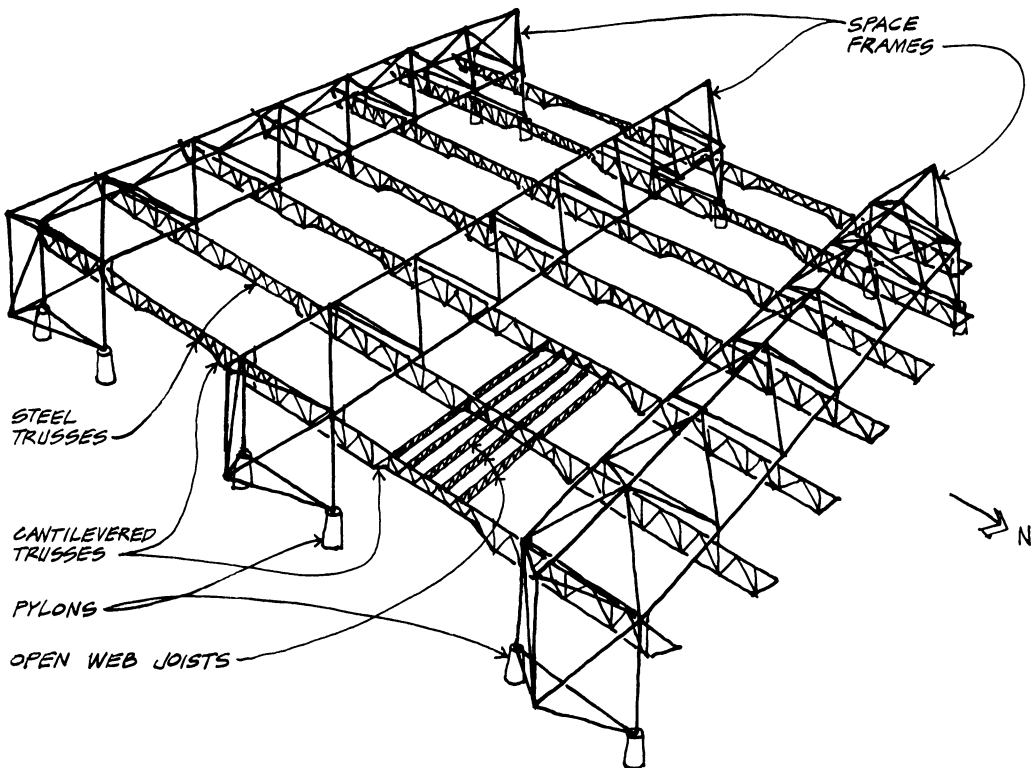
4.4 Diagrammatic Layout of Structure of the Kemper Arena

The basic structural elements supporting the loads of the roof itself and those acting on it, as well as the weight of the upper part of the walls of the arena, were three external space frames spaced at 153 ft. (46 m) in the north-south direction in the shape of rectangular portals, 360 ft. (108m) long in the east-west direction, and 81 ft. (24 m) high (Fig. 4.4). The horizontal element, or beam, of the portals consisted of a *space frame* of steel tubes with an equilateral

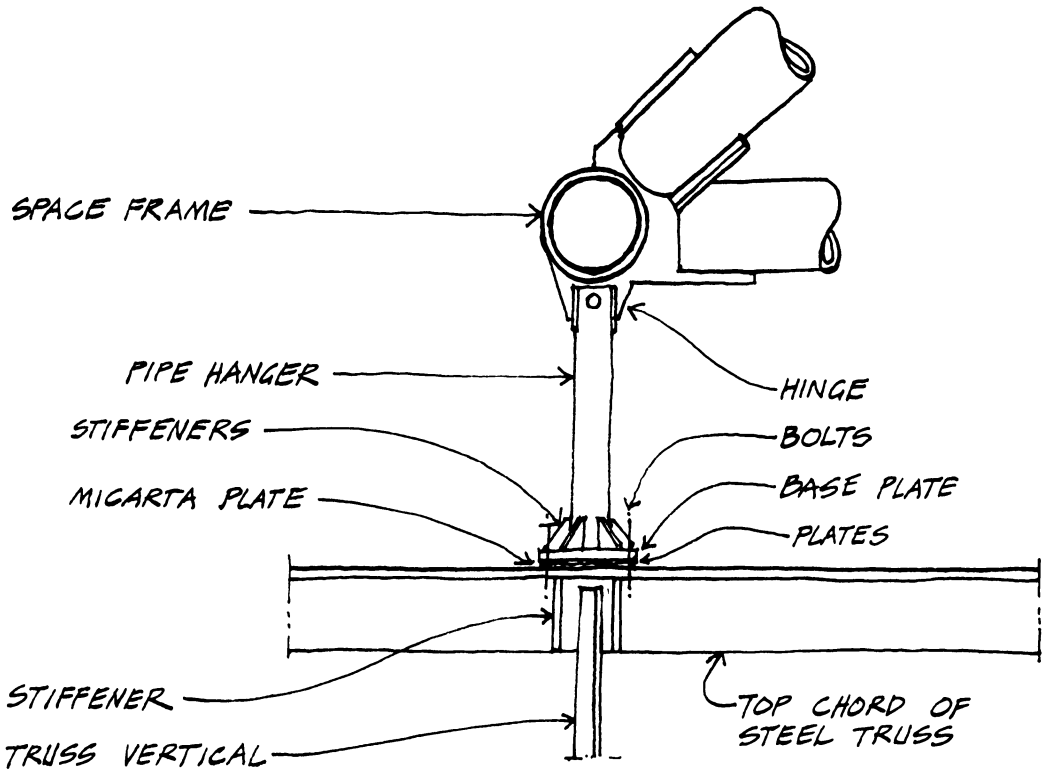
4.6 Components of the Hanger Assembly

The hanger assembly, because of its two essential functions, does not consist of a simple rod as the word “hanger” may have implied to the reader (Fig. 4.6). Since the weight of the roof itself is 26 psf (1.3 kN/m²), or about 1,500 tons, and since the roof was designed to carry 25 psf (1.25 kN/m²) of additional load caused by rain, the load of the mechanical systems, and other hanging loads (or about

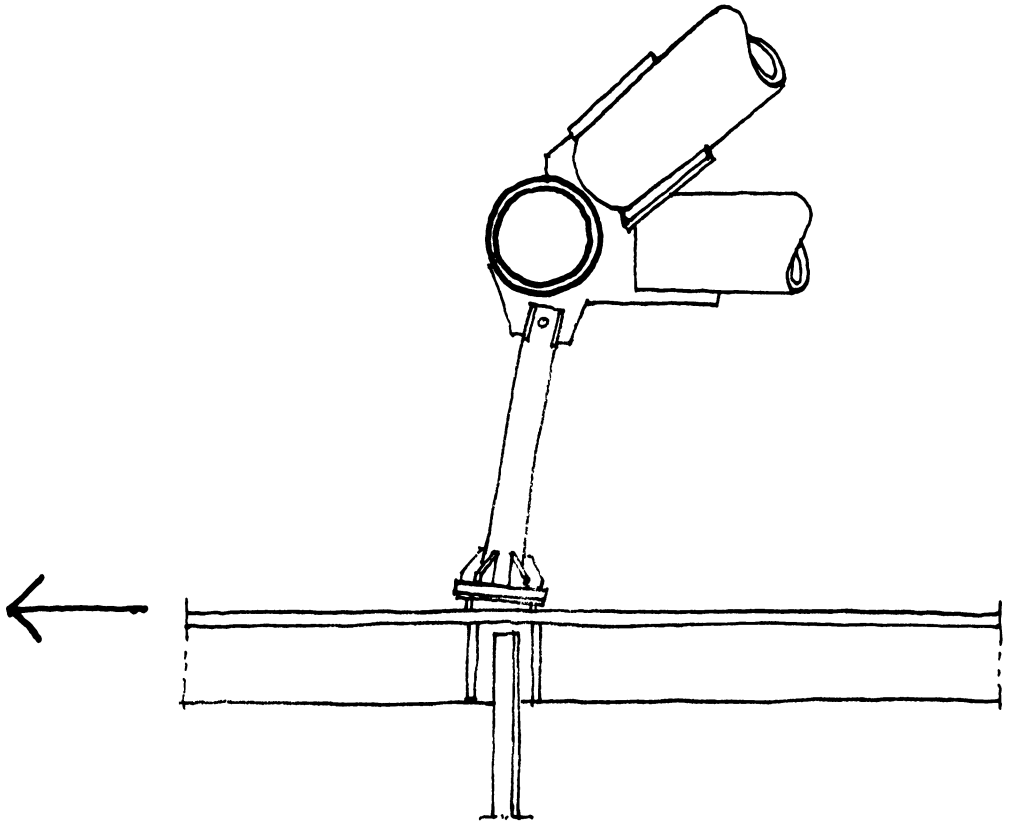
4.7 Hanger Assembly: bent by Lateral Force

another 1,500 tons), then each of the forty-two hangers was to support in *tension* 140,000 lb. (622 kN). Moreover, they had to resist the horizontal, variable wind forces (exerted on the roof and on the upper part of the walls hanging from it), which tended to move the roof horizontally as a gigantic pendulum. For this purpose six of the hangers were hinged both at their top and about halfway down their length, while the remaining thirty-six were hinged only at the top and connected (almost) rigidly to the top chord of the large trusses. While the two-hinge hangers allowed the roof to move as a pendulum, the single-hinge hangers limited the horizontal roof motions to the *bending* deflections of these hangers (Fig. 4.7).

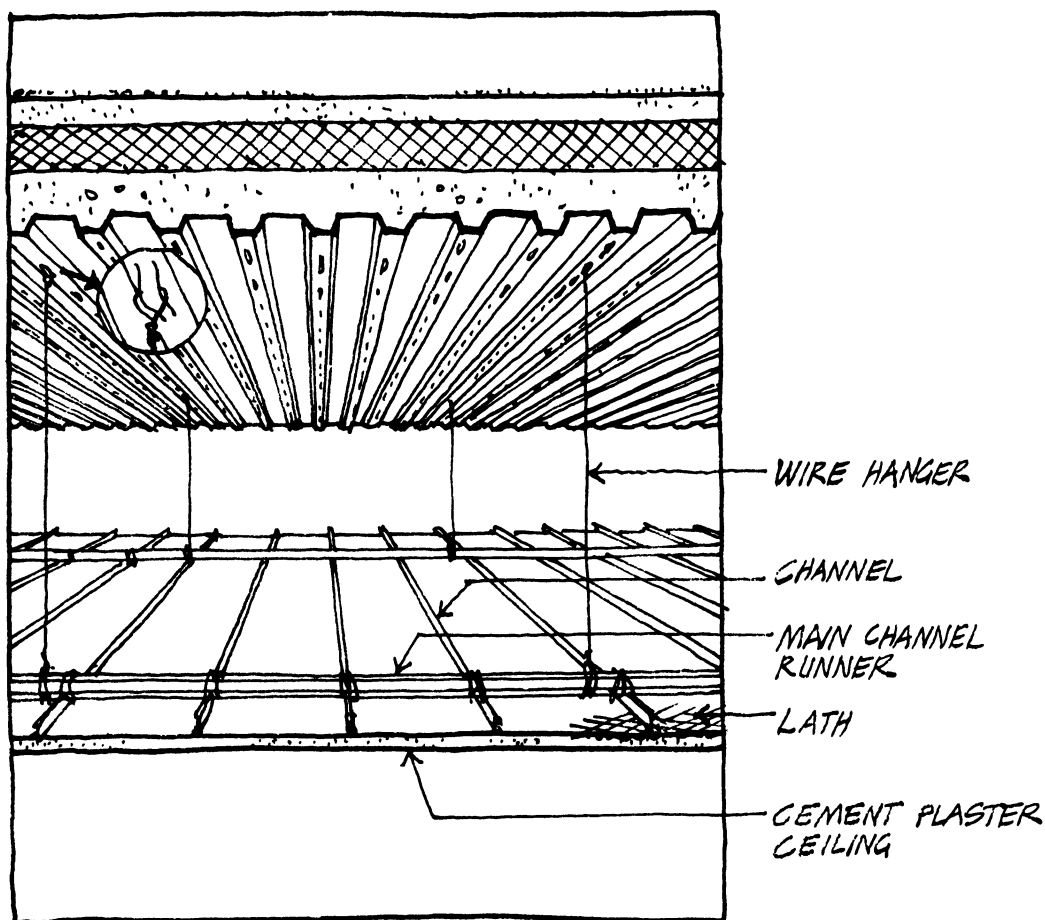
4.9 Components of the PATH Railroad Station Ceiling

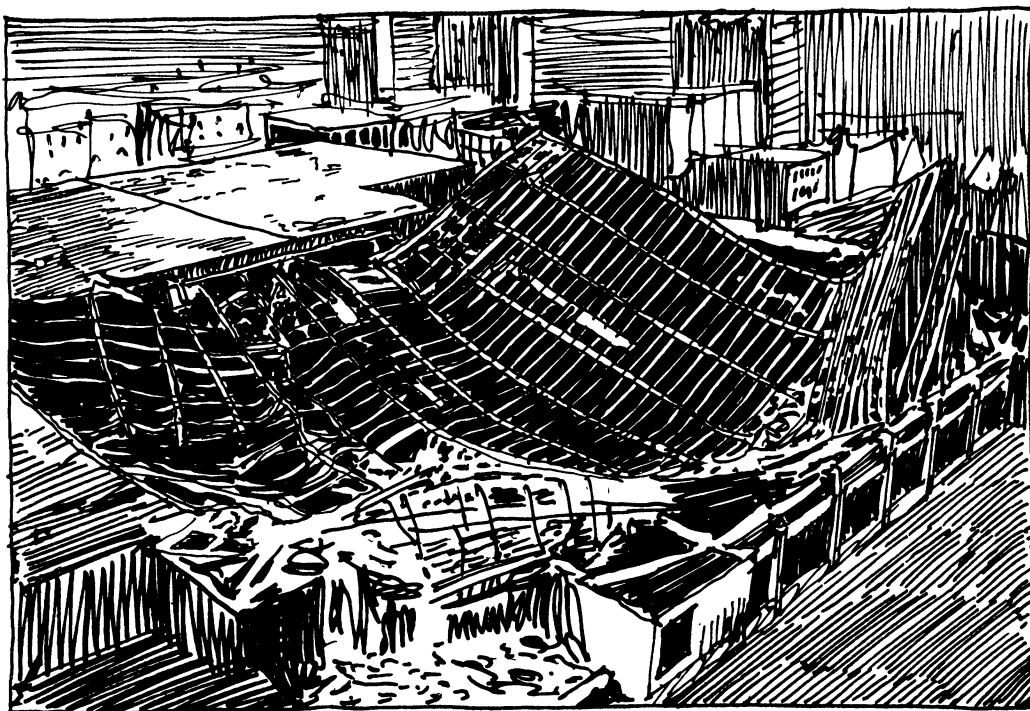
4.10 Hartford Center Roof: after the Collapse

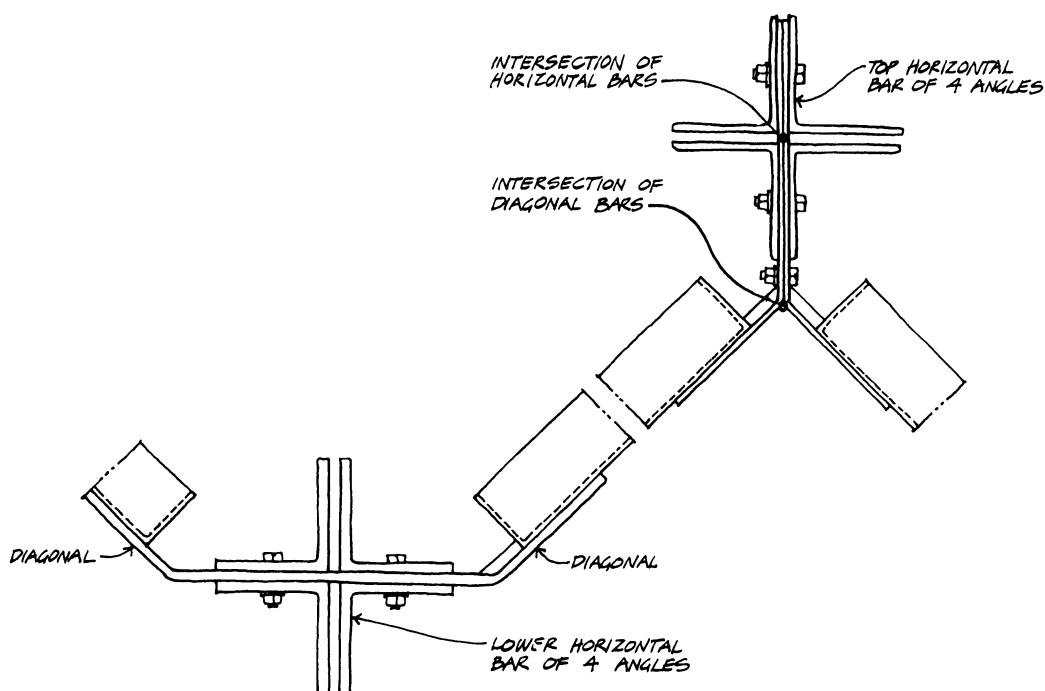
4.13 Diagonals Eccentrically Connected to Cross-Shaped Chords

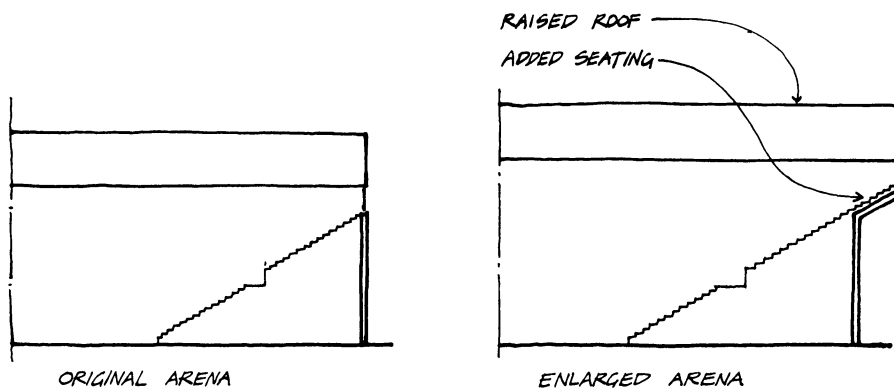
4.15 Section through Original and Enlarged Arena

Once the wreckage was cleared away, the firm of Ellerbe Architects of Minnesota began planning for a new arena. True to the promise of the city fathers, it was bigger, seating four thousand more spectators than the old one. Its roof was simpler, with two ordinary parallel vertical trusses sitting on the same four pylons raised up 12 ft. (3.6 m) to fit the grander facility (Fig. 4.15). Secondary trusses were framed into these primary trusses at six locations, and tertiary trusses framed into the secondary ones, resulting in a grid of trusses bearing a family resemblance to the original roof. The revamped coliseum began to take shape sixteen months after the collapse and by the spring of 1980 was ready to receive its first guests, the fans of a local hockey team that had been homeless for over two years.

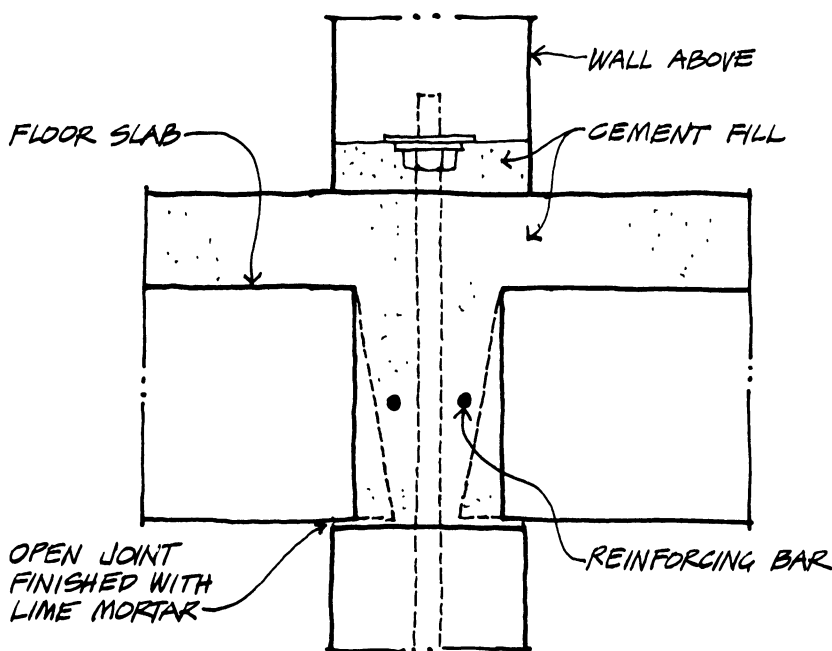
5.3 Joint between Interior Wall and Floor Slabs

push a wall panel off the floor. Since the explosion in Miss Hodge's apartment did not damage her eardrums, it was deemed to have caused a pressure against the wall panels of less than 10 psi (0.07 N/mm²). Yet tests showed that this pressure, equivalent to that felt when one swims under only 10 ft. (3 m) of water, was high enough to cause the failure of a reinforced concrete wall either by bending it or by overcoming the friction resulting from the gravity loads and kicking it out. Tests conducted by experts from the tribunal established by the government to determine the cause of the collapse showed that the wall panel would slide out against the floor panel at a pressure of 2.8 psi (0.02 N/mm²), less than one-third that of the explosion. A witness in a nearby factory reported seeing the wall of Miss Hodge's living room "come out as if pushed sideways and then fall," which is consistent with the fact that the strength of the wall panel in bending was greater than the resistance of the joint in friction. Had the explosion occurred on a lower floor, the loads compressing the wall panels and the resulting friction might have been large enough to have prevented a failure of the wall by sliding.

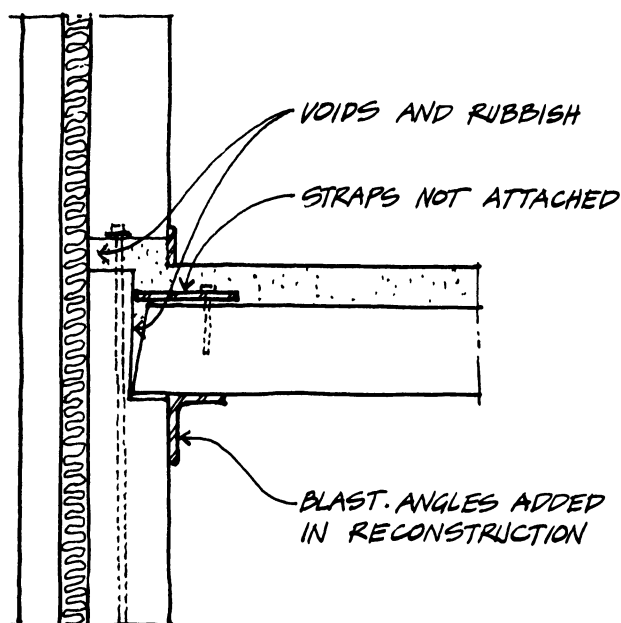
5.4 Joint between Floor Slab and Outside Wall—Reinforced after the Blast

The need to strengthen Ronan Point was obvious, but discussions about what to do and who should pay for the remedial work moved the matter into the sociopolitical arena. Within a year of the disaster the debris was cleared away, and the wing rebuilt with a *blast angle*, a reinforced joint detail preventing the separation of the wall from the floor. The tower was reoccupied; but in 1984 cracks began appearing in other walls, and the entire tower was evacuated. Eventually, in May 1986, the building, which the press had dubbed the "Infernal Tower," was swathed in a coat of reinforced polystyrene to contain the dust of demolition, and the tower was demolished, floor by floor, in a procedure that reversed that used in construction. Forty-one weeks later only the foundations remained, a monument to a failed dream of industrialized construction gone only eighteen years after its erection. Since it would have cost six times more to strengthen the tower in accordance

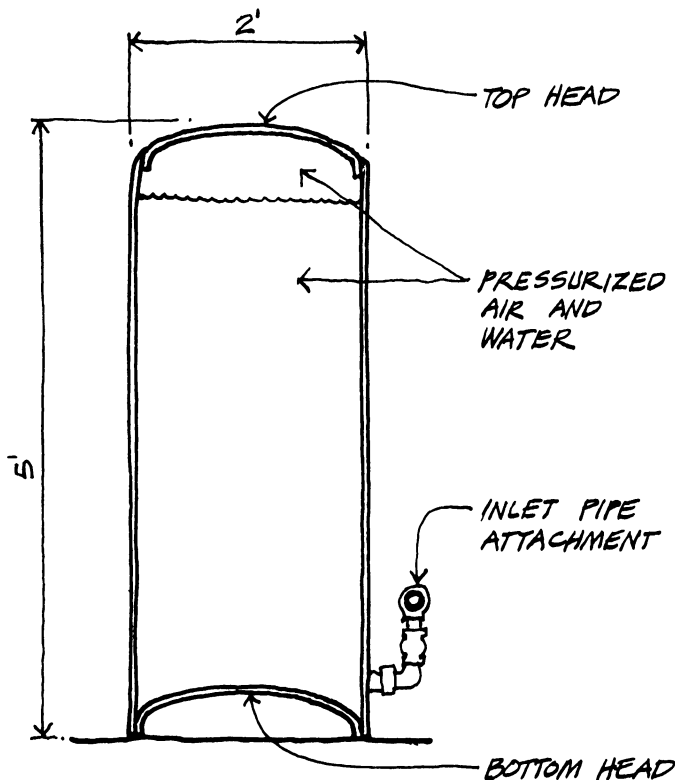
5.5 Hydropneumatic Tank

Very early on the morning of the blast an employee of the photo lab went to the basement and closed the safety switch on Tank No. 2, instantly starting the pump, but when he returned to the lab on the sixth floor, he noticed that the pressure gauge there showed almost no pressure in the system. He went right back to the basement to check the problem and found Tank No. 2 lying on its side on the floor and water flooding the area from a broken pipe that had been connected to the tank. He also smelled gas. He left immediately to call for help, but before he could reach the lobby, a powerful explosion engulfed him in dust and flying debris.

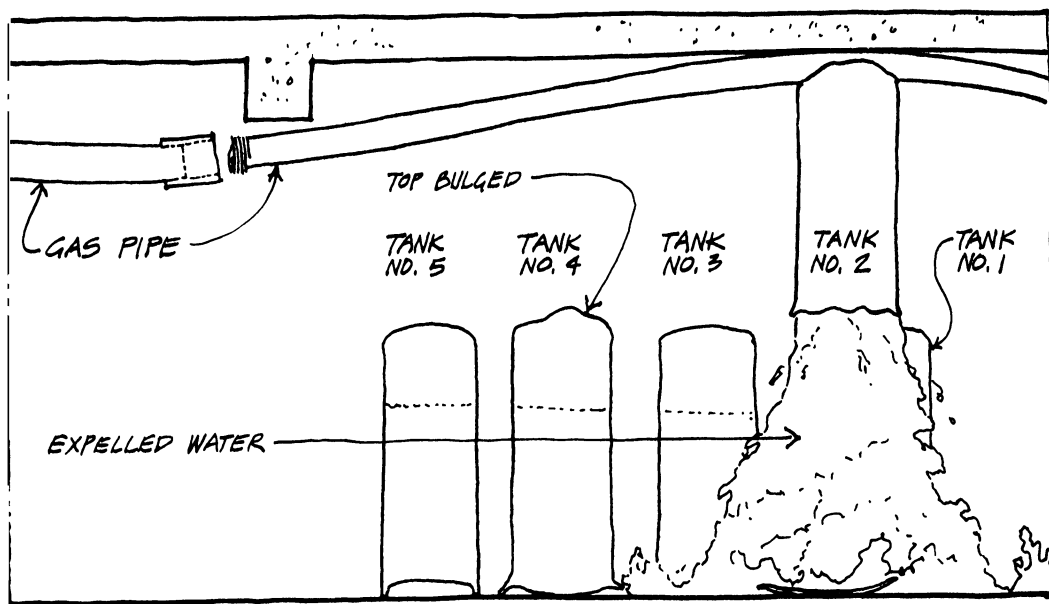
5.6 Ruptured Tank Striking the Gas Pipe

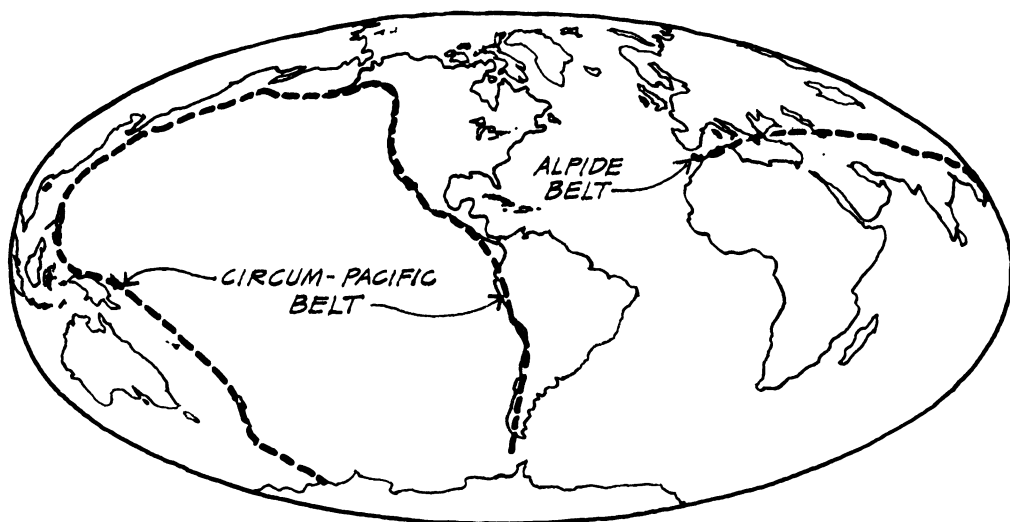
6.1 World Seismic Bands

The earth's crust is like a broken eggshell floating on the viscous inner magma of melted rock. Plate tectonics, the recently developed theory of movements of the earth's crust, offers the most plausible explanation for the existence of bands all over the globe along which most earthquakes occur. These bands contain *fault lines* or cracks that are, in fact, the edges of the tectonic plates and, as correctly observed by Strabo, occur primarily along continental coasts (Fig. 6.1). These giant plates move relative to one another

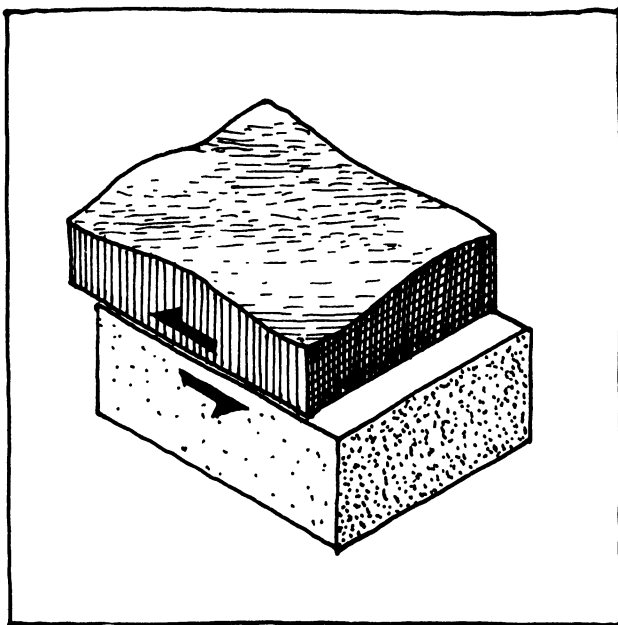
6.2c Subduction/Thrust

about as fast as one's fingernails grow, grind against each other both vertically (thrust) and horizontally (slip), and sometimes try to climb one above the other (subduction) (Fig. 6.2). Since the plate boundaries are not smooth, the movements are inhibited by friction, resulting in the storage of energy caused by the unreleased movement, somewhat like that in a stretched rubber band. Over time this energy accumulates until the frictional resistance generated by the roughness of the plate boundaries is overcome and the pent-up energy is suddenly released (the rubber band snaps), causing an earthquake. Predicting where, when, and how violently this event will take place is the major goal of geologists concerned with seismology (from *seismos*, Greek for "earthquake"). They are beginning to be quite successful in answering the questions of where and how violently, but not yet of when. They have correctly predicted the location and energy content of the last twelve major earthquakes in the world, but time uncertainty, despite rapid improvement, is still within thirty years.

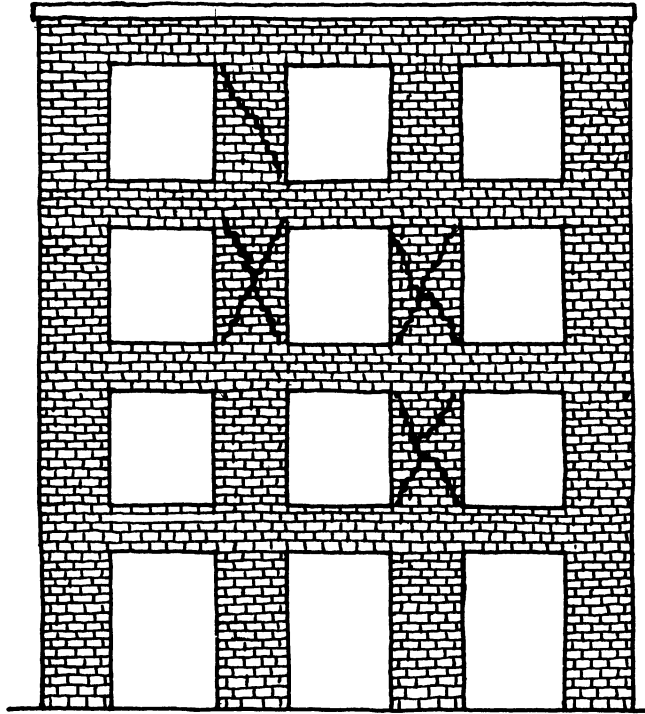
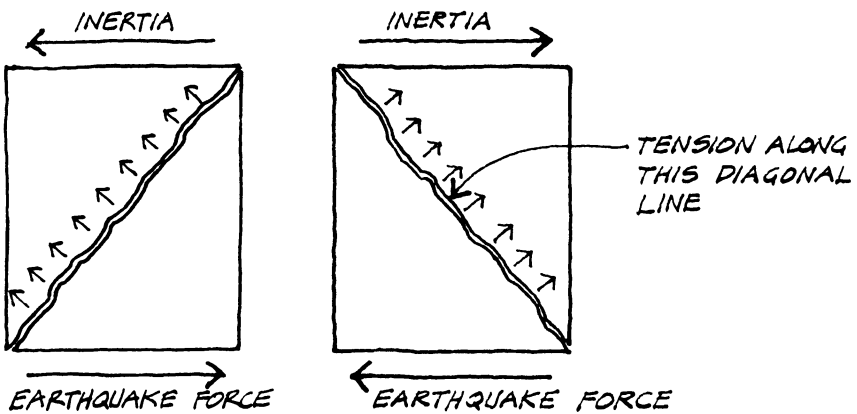
6.4 Diagonal Cracking of Masonry Wall

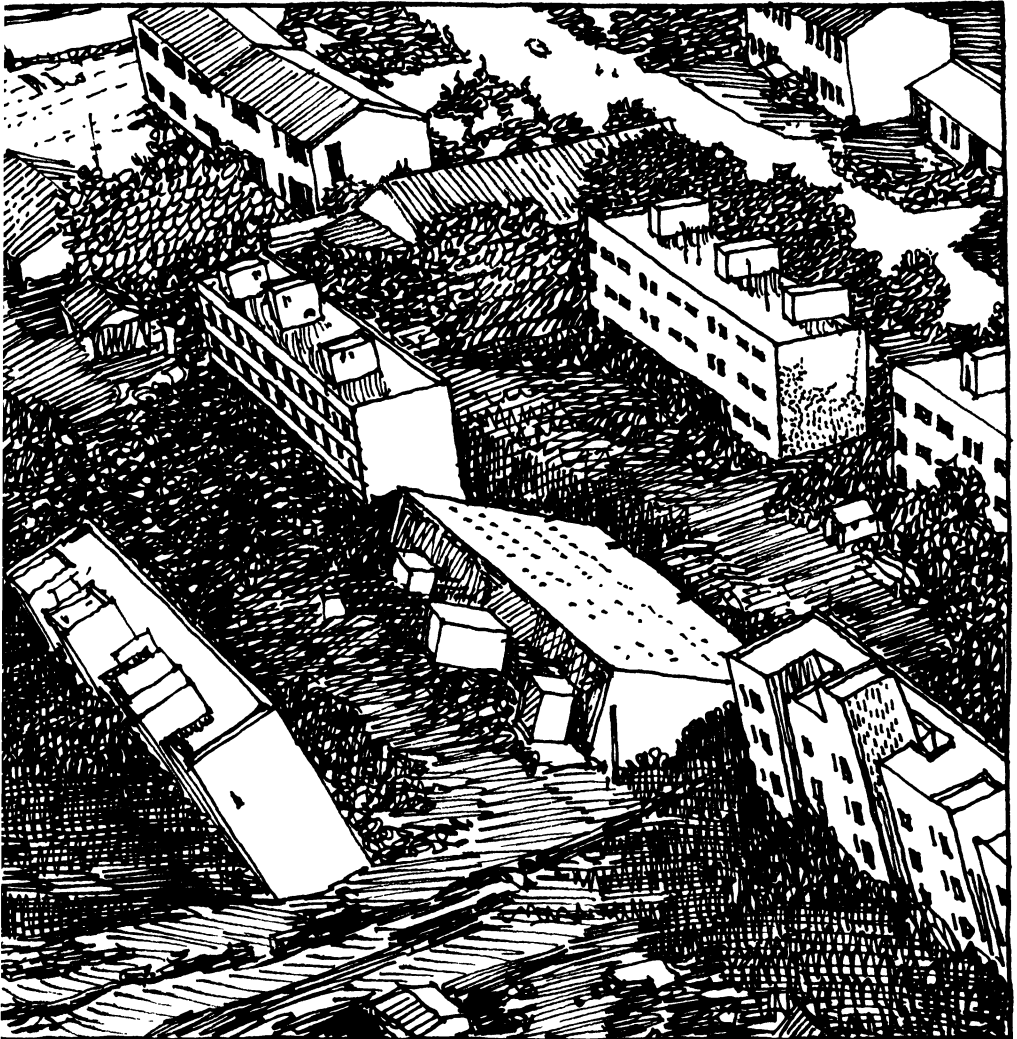
6.6 Nigata Apartment Buildings: After the Earthquake

urated with water that suddenly become liquid when subjected to shaking from the quake. To demonstrate this action, place a weight on a pot full of sand to which water has been added almost to the top. Shaking the pot will cause the sand-water mixture to liquefy and the weight to sink and/or tilt. This is precisely what happened in Nigata, Japan, in 1964, when an apartment building tilted through an angle of 80° from the vertical without breaking up, so that after the movements stopped, the occupants were able to walk to safety down the face of the building (Fig. 6.6).

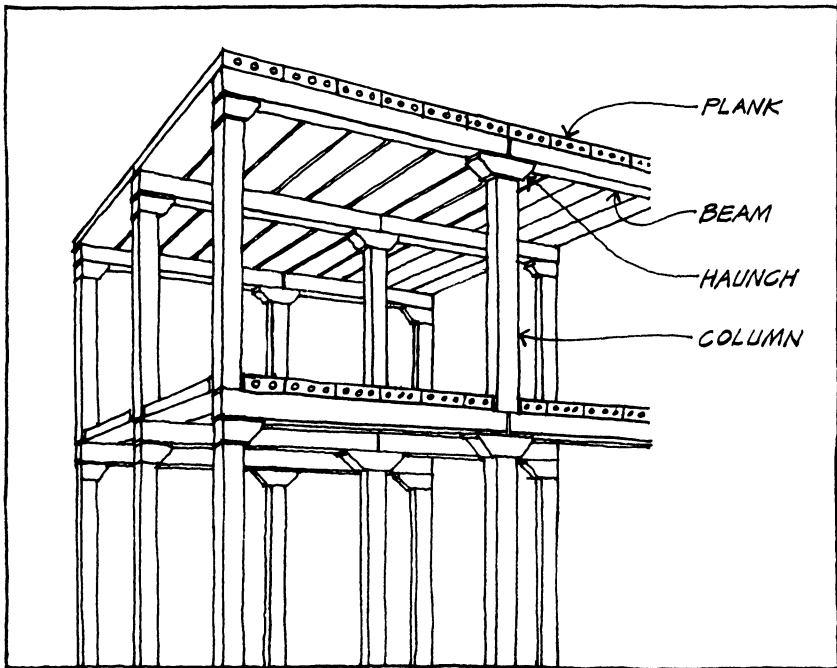
6.7 Precast Concrete Frame Construction

The earthquake of December 7, 1988, near Spitak, Armenia, with a magnitude of 6.8, had a duration of strong motion of only ten seconds but was devastating, causing the deaths of more than twenty-five thousand people, most of them trapped in schools, apartment buildings, and public buildings. Of the three cities damaged by the shock, Leninakan, located farthest from the shock (20 miles [32 km]), was more severely damaged than Kirovakan, 16 miles (25 km) from the rupture zone. Leninakan lies in a broad alluvial plain and is underlain by deep sedimentary formations in what may have been an ancient lake. Kirovakan has a thin soil layer above a rocky base. The softer soils in Leninakan magnified the intensity of the shock and resulted in over 50 percent of the structures collapsing or having to be demolished. The most vulnerable structures turned out to be those consisting of precast concrete columns and beams joined to create frames nine to twelve stories high. Precast hollow-core concrete slabs spanned between these frames to create floors (Fig. 6.7). Almost all these housing blocks (there were 133 in Leninakan) collapsed or were so seriously damaged as to be unsafe and had to be demolished. An examination of the debris revealed that all the joints in the precast construction were weak; there was no connection between adjacent

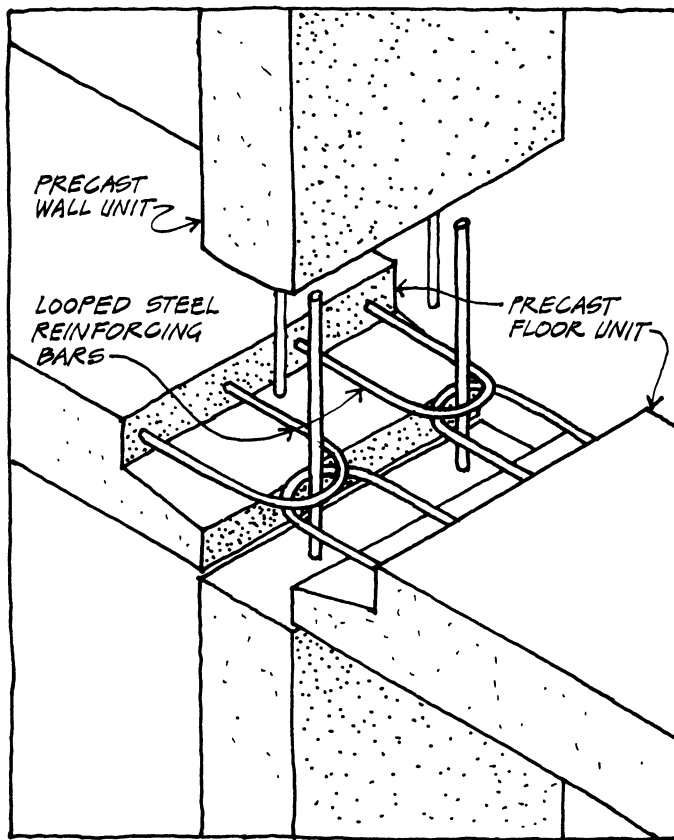
6.9 Detail of Joint between Precast Concrete Wall and Floor Panels

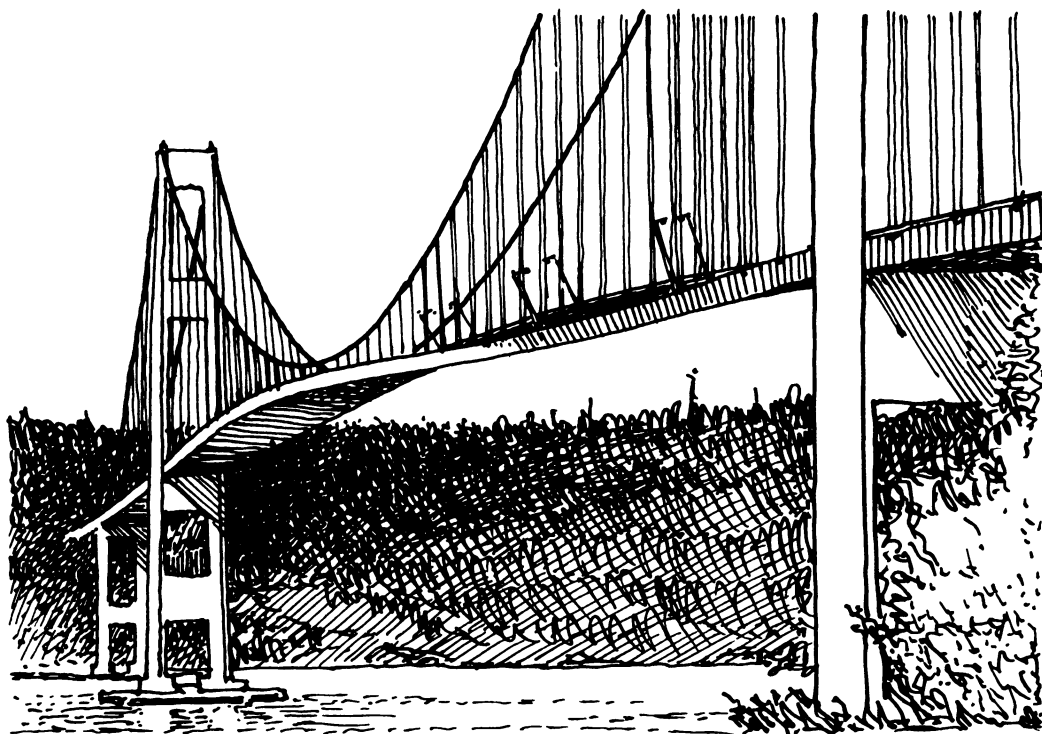
7.3 Twisting Motion of Tacoma Narrows Bridge

circular arc. Shortly before 10:00 A.M. Arkin again checked the wind velocity and saw that it had increased to 42 mph (67 km/h) and that the movement of the bridge deck had heightened dramatically; by his count, the deck rose and fell at the center of the bridge 38 times per minute with a 3 ft. (0.9 m) amplitude. Greatly concerned, Arkin halted all traffic, and Professor Farquharson, who happened to be at the site that day, observed that the up-and-down motion of the center span consisted of at least nine vertical undulations while the bridge was also deflecting laterally by as much as 2 ft. (60 cm). Suddenly the bridge started twisting violently, and the nine-wave motion changed to a two-wave motion while the bridge deck near the Tacoma side appeared to twist to an almost 45° angle (Fig. 7.3).

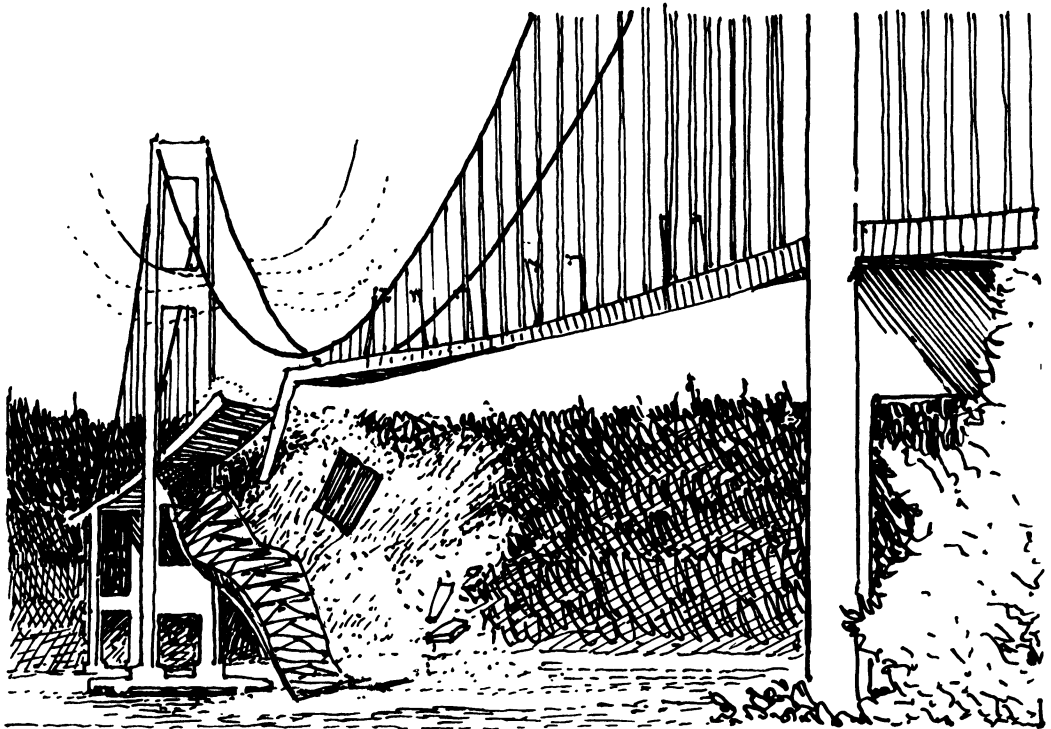
7.4 Tacoma Narrows Bridge at the Moment of Collapse

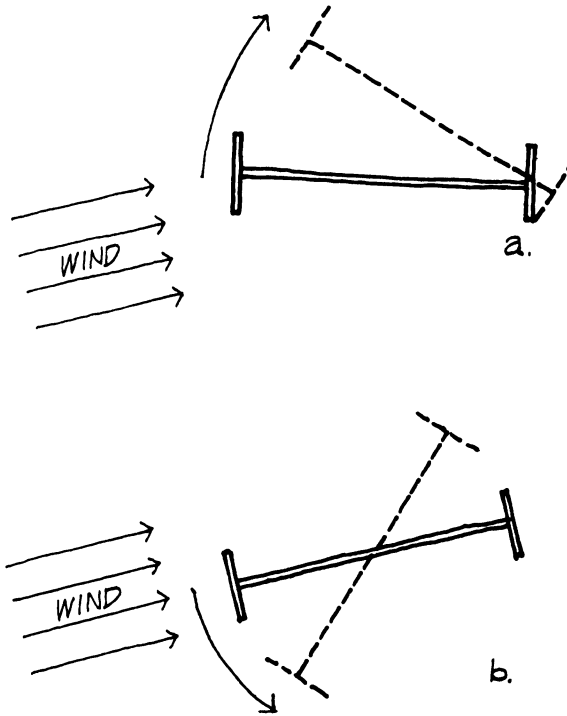
7.6 Wind-Induced Twist

* Recent (1991) studies suggest that the cause may be attributable to vortex shedding, a phenomenon first described by Theodor von Karman. Spiraling vortices can be seen in the wake of a ship moving through water, and similar, though invisible, vortices trail an airplane wing in flight. Two kinds of vortices were shed by the twisting Tacoma Narrows deck. The first is called a Karman vortex street because the periodic shedding creates a continuous pattern of alternating vortices. However, these vortices were out of sync with the natural frequency of the bridge and therefore could not contribute to a buildup of motion. The second was a flutterlike complex pattern of vortices with a frequency coincident with the bridge’s natural frequency that rapidly reinforced the destructive torsional oscillations. It is difficult to state whether the twisting oscillations of the deck caused these vortices or whether the vortices caused the deck oscillations, but at the present time this new assumption must be considered the best interpretation of the cause of the collapse.

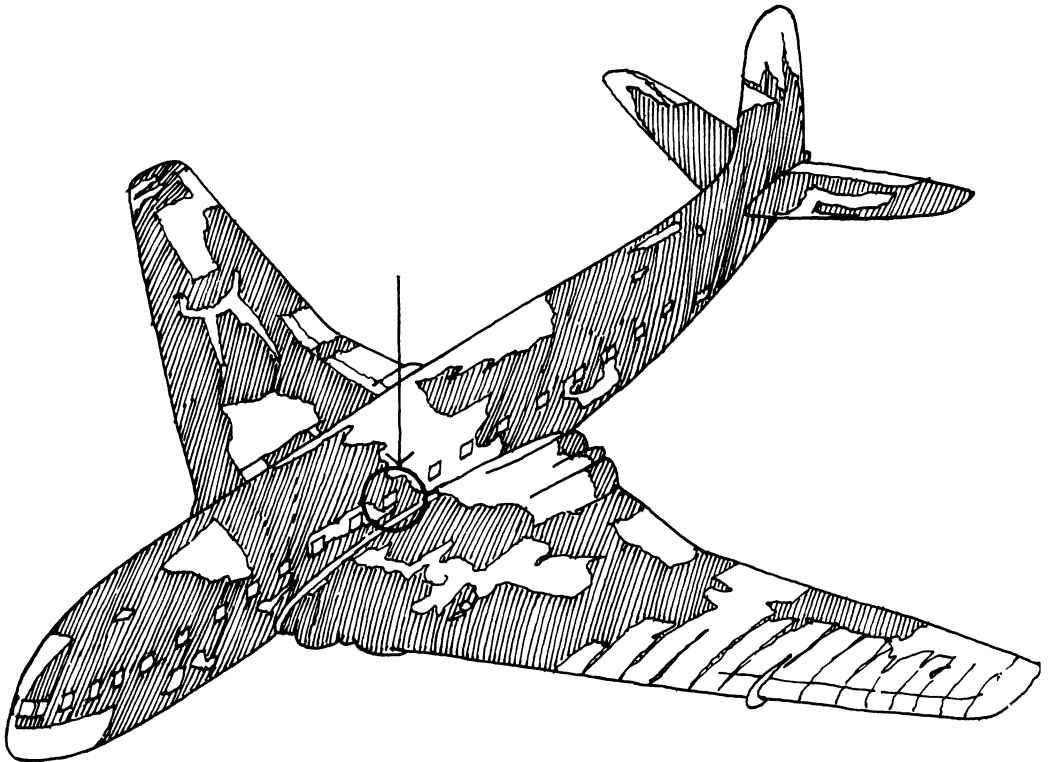
8.1a Comet Airliner with Recovered Sections Shown Shaded

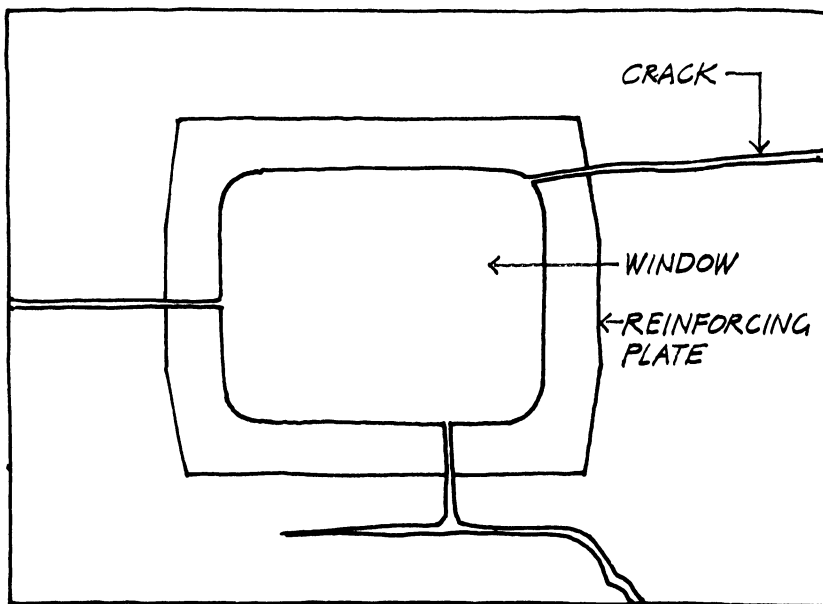
8.1b Cracks around Window

De Havilland had tested samples of the corner panel and an entire fuselage section of each plane, concluding that in terms of fatigue the cabins were good for a service life of about ten thousand flights or ten years. After the accident a test performed by the RAE showed failure after only three thousand cyclic load applications. This result, although only one-third of de Havilland's estimate of the fuselage's fatigue life, was still three times larger than the thousand-load applications experienced by the last two crashed Comets. Why this incompatible difference? Because, first, the de Havilland test did not accurately represent the actual cabin since complete windows were not fitted into the test section. Then there

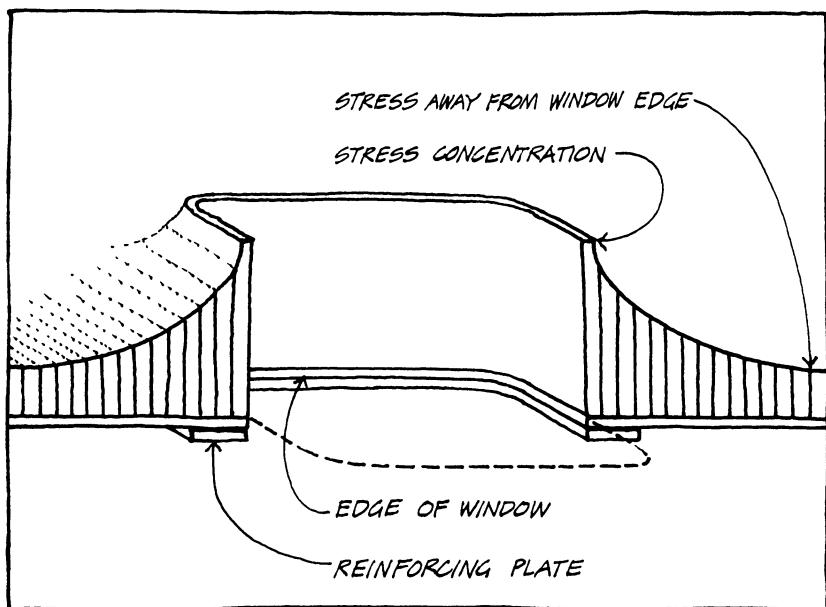
8.2 Stress Concentration at Window's Edge

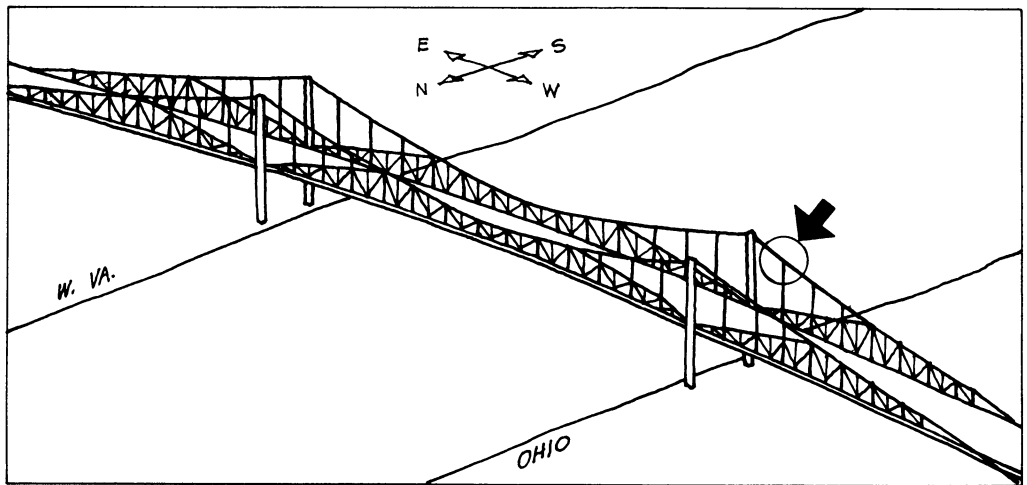
8.3 Point Pleasant Bridge

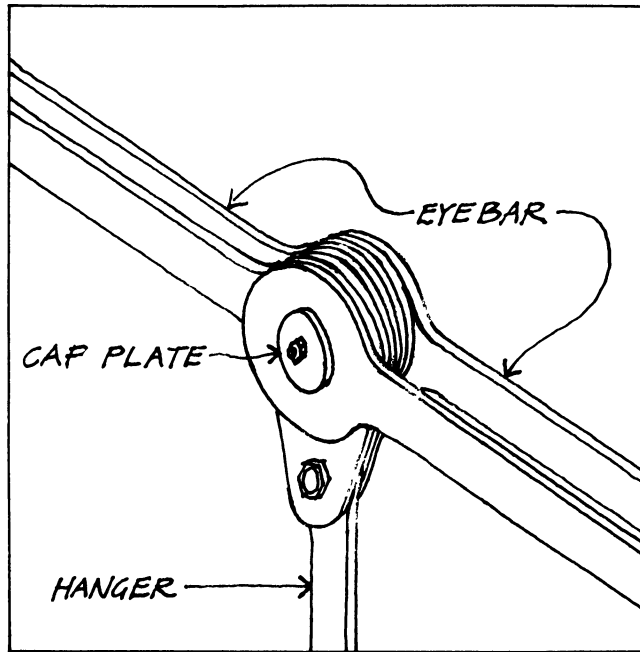
8.4 Typical Eyebars Joint

Modern suspension bridges use steel cables introduced by French engineers around 1830, but the Point Pleasant Bridge, like other U.S. suspension bridges of the time, was supported by two steel chains, each consisting of 50 ft. (15 m) long *links* with *two* parallel forged steel eyebars each. (A cable today generally consists of thousands of individual wires.) An *eyebars*, as the name implies, is an iron or steel bar with enlarged ends pierced by holes; a pin through the holes of adjoining links, 12 in. (300 mm) in diameter in the Silver Bridge, connects them to make a chain and is held in place with bolted cap plates (Fig. 8.4). The Silver Bridge had a central span of 700 ft. (213 m), with two 380 ft. (116 m) side spans, and approach spans supported by piers at either end of the bridge leading to the anchorages for the eyebar chains. As originally built in 1928, the two-lane bridge had a timber deck and two sidewalks. For added durability, the roadway was replaced in 1941 with a
