WHY BUILDINGS FALL DOWN

How Structures Fail

MATTHYS LEVY
and
MARIO SALVADORI

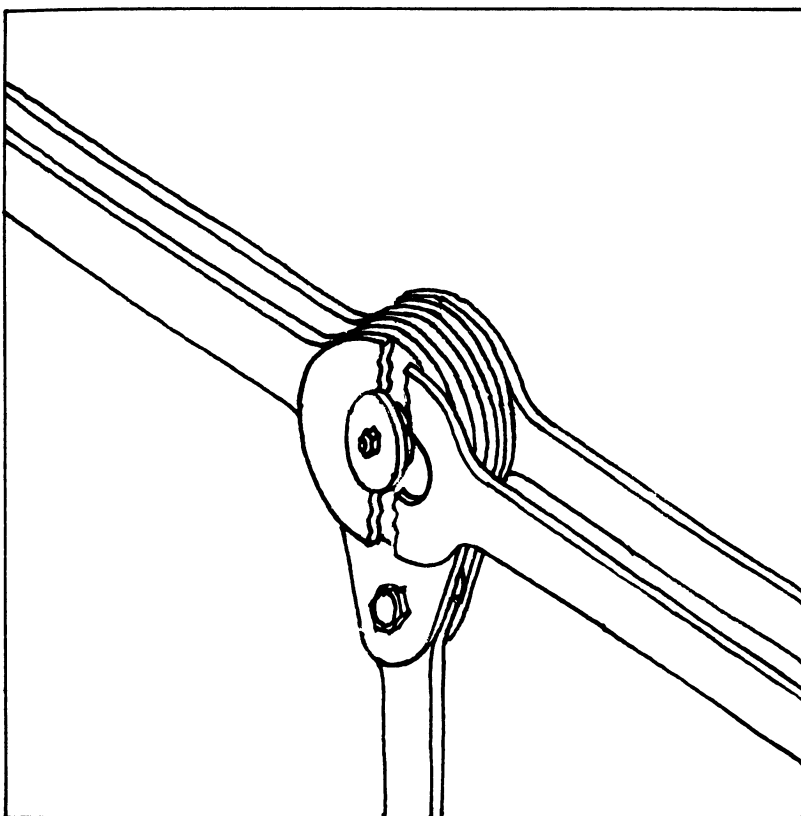
8.7 Cracked Eyebar

The need to discover the cause of the Point Pleasant failure led to the decision to salvage and store as many elements of the fallen spans as possible. Fractured, bent, and rusting segments were reassembled into a giant jigsaw puzzle on a 27 acre (10.9 ha) field near the banks of the Ohio. The inquiry panel and its consultants, some of the best bridge engineers and scientists in the country, had the task of locating the bar that broke first. Laboratories were engaged in the conduct of microscopic examinations of the steel in

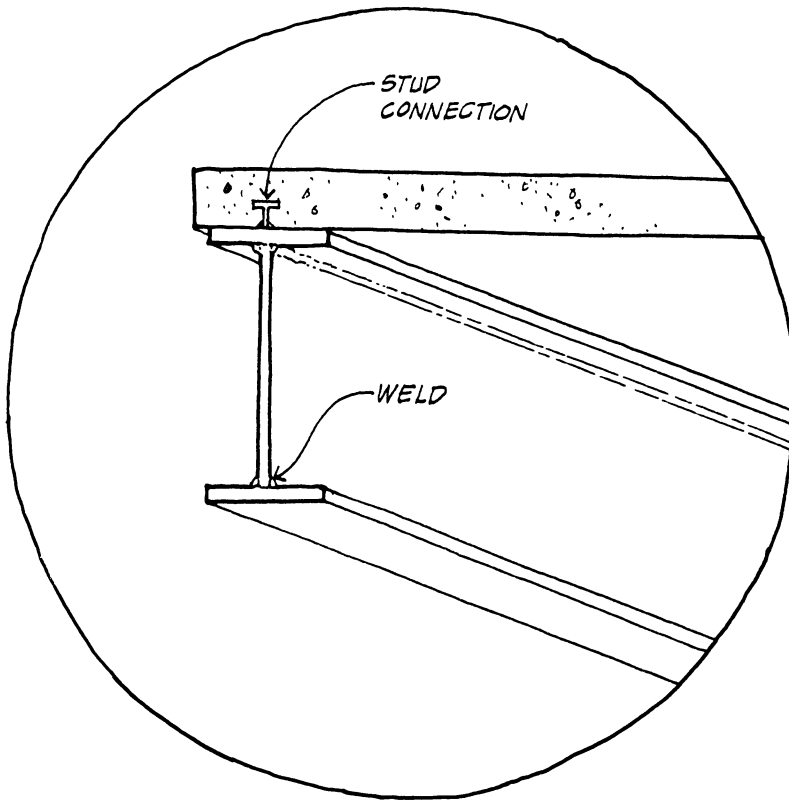
9.1 Typical Welded Bridge Girder

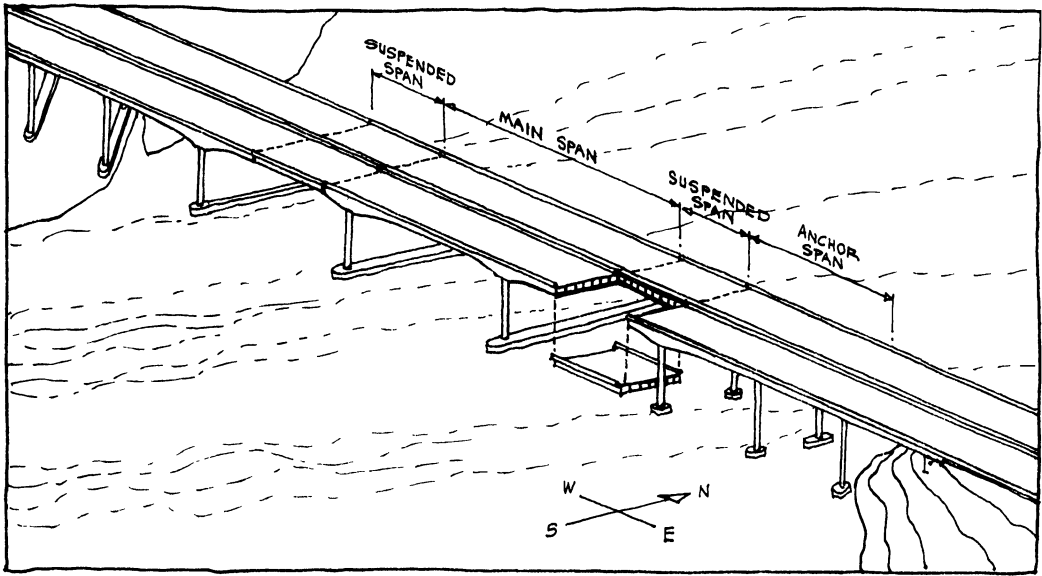
9.2 Mianus River Bridge, Showing Collapsed Section

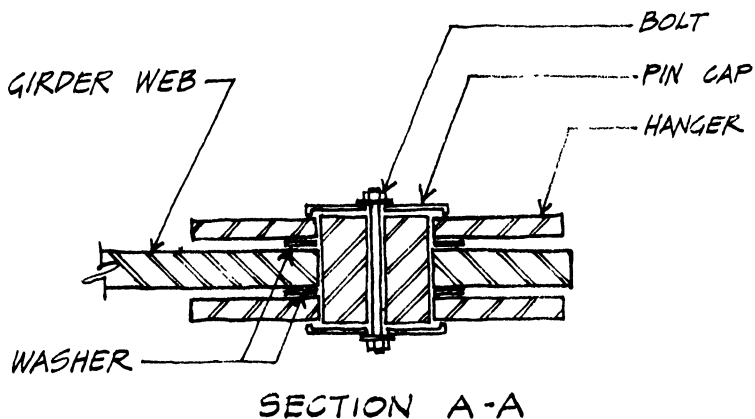
9.4 Pin and Hanger Assembly: Elevation and Cross Section

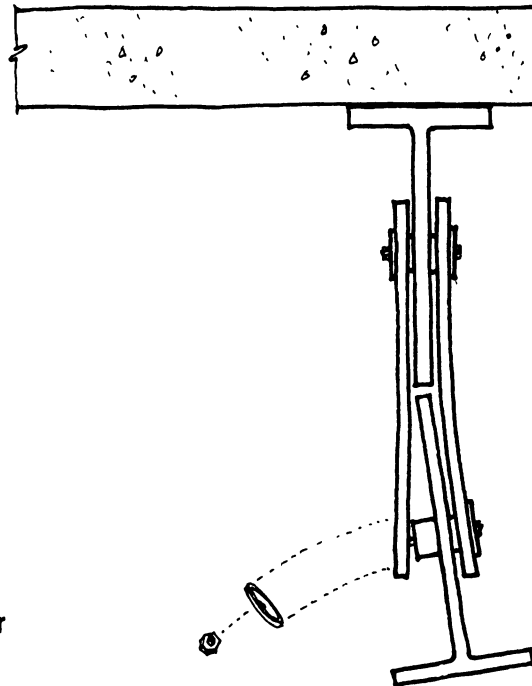
9.6 Failure of Hanger

We can now reconstruct the events leading to the collapse of the Mianus Bridge. Over the bridge's twenty-five years, corrosion builds up between the hanger plates and the pins because of the constant wetting action of rain, brought on by the paving over of the floor drains. Each time a car or truck passes over the bridge, the skew effect imposes a lateral force on the hanger plates, contributing to the tendency of the hanger plates to be pushed off the pin. At the southeast corner of the suspended span, the force of corrosion, aggravated by the skew effect, is so large that it causes the restraining pin cap to dish out and possibly pop off. Sometime before the collapse, hours or days earlier, the bottom of the inside hanger plate slips off the pin (Fig. 9.6), causing a transfer of the

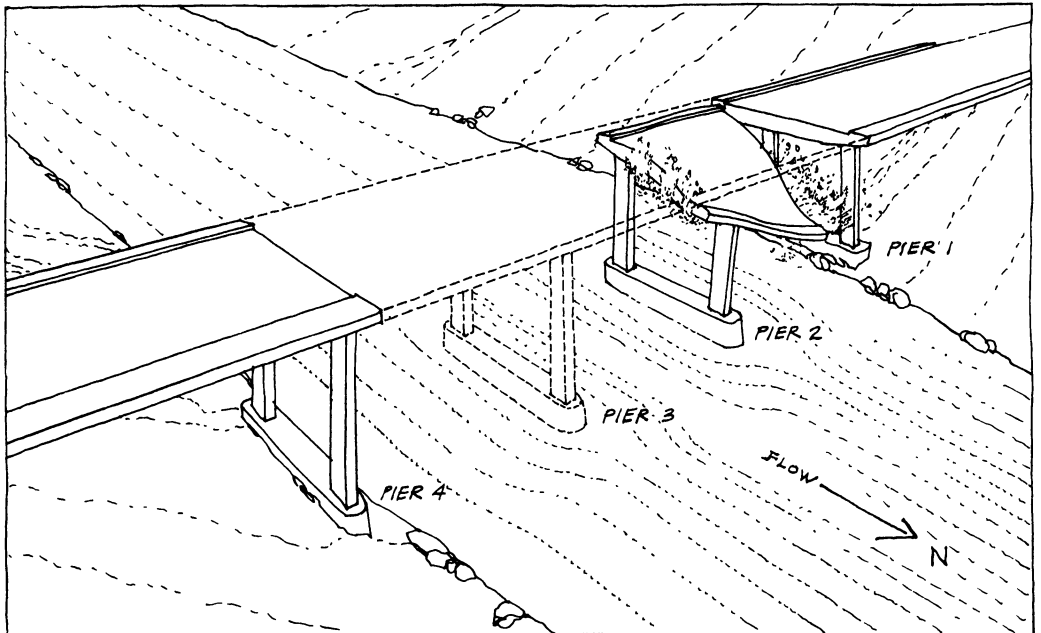
9.9 Collapsed Schoharie Bridge

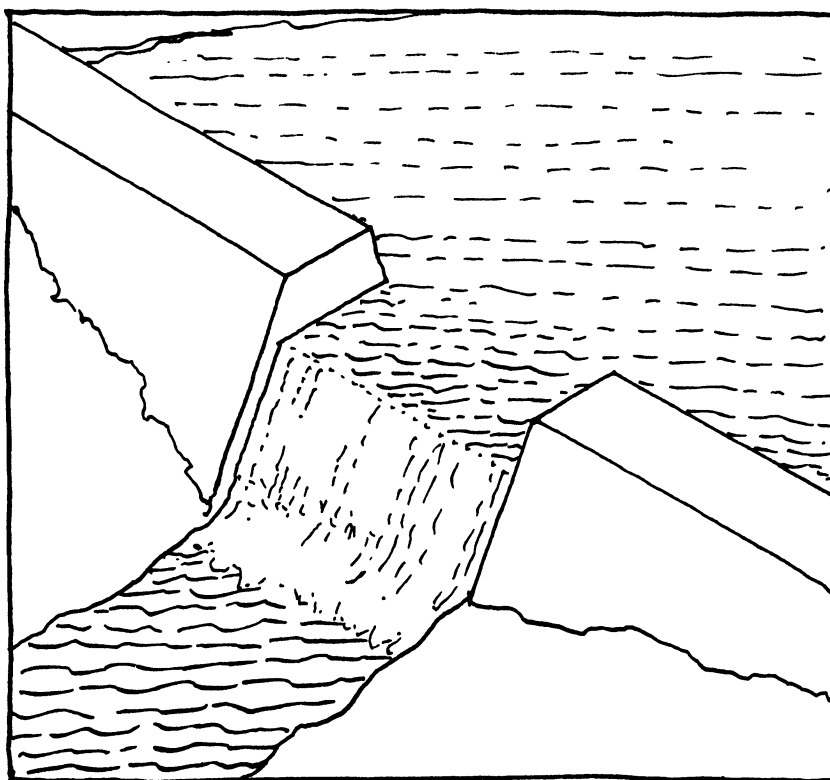
11.1 South Fork Dam: Original Construction

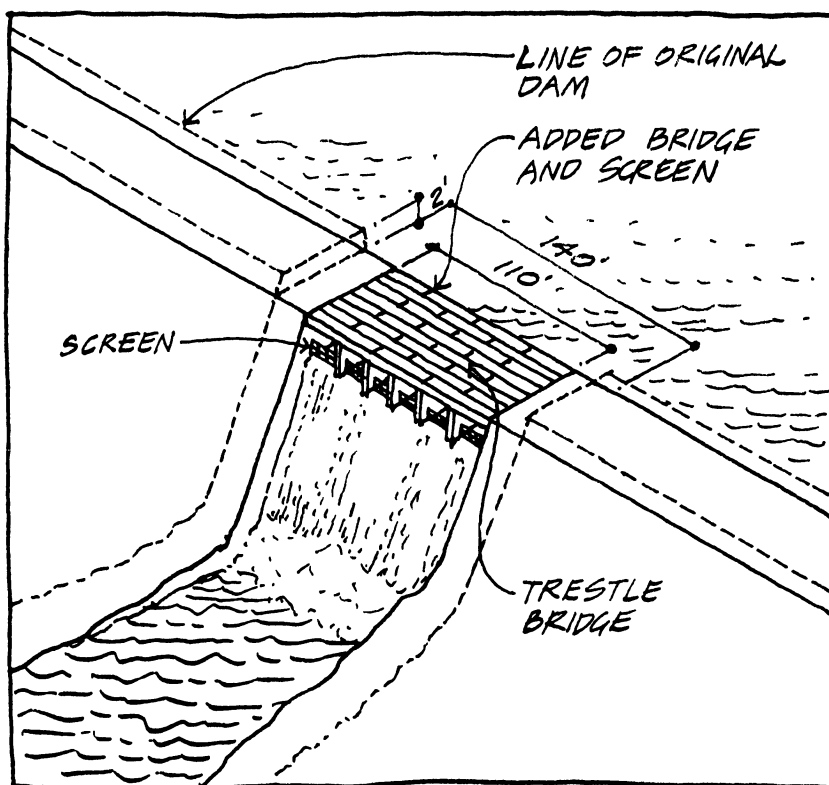
11.2 South Fork: Modified Dam and Spillway

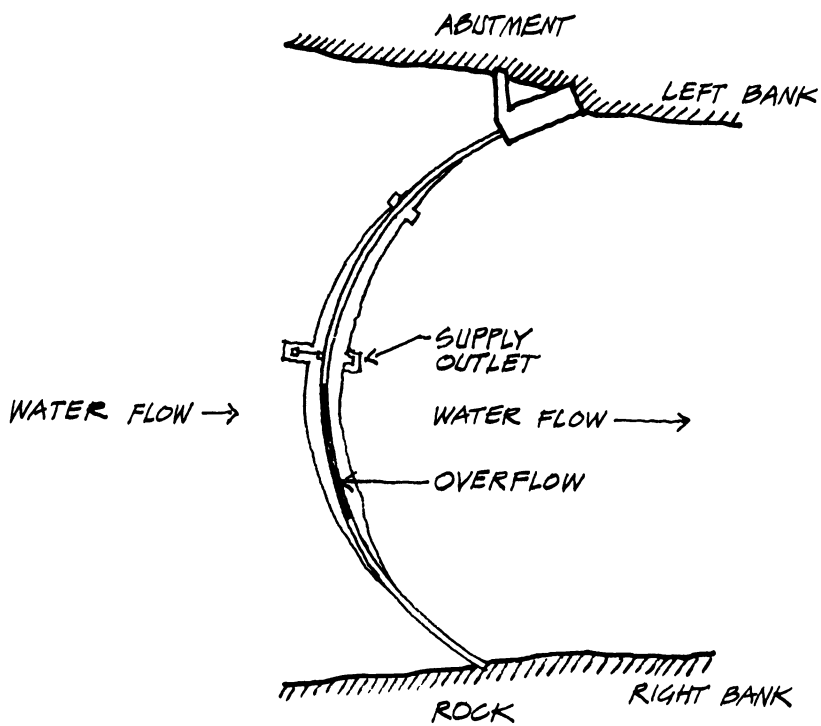
11.4 Plan of Malpasset Dam

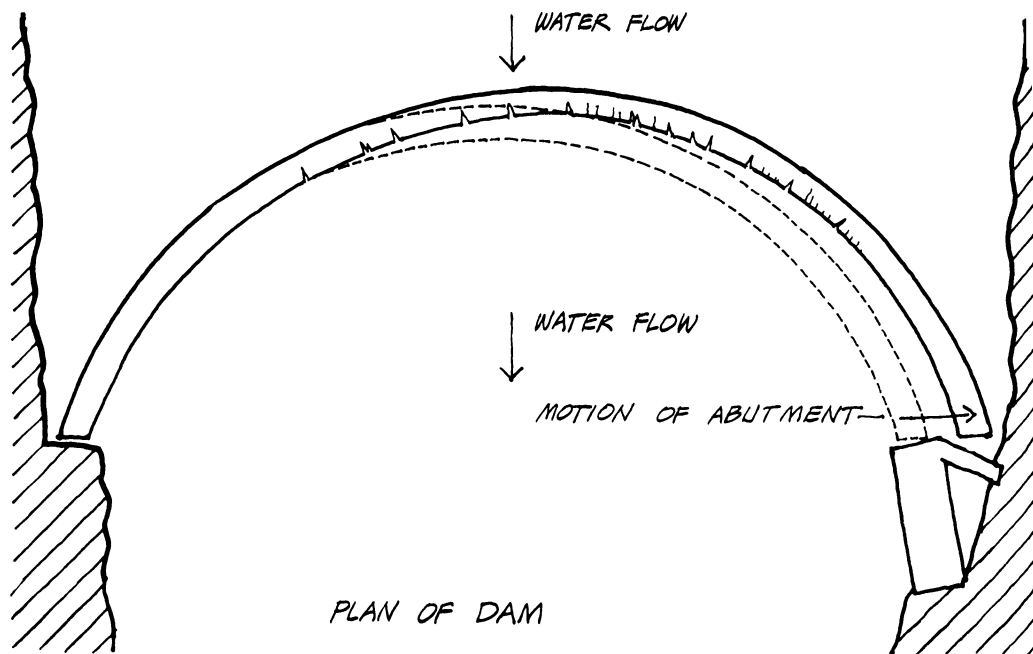
11.6 Failure of Arch Owing to Displacement of Abutment

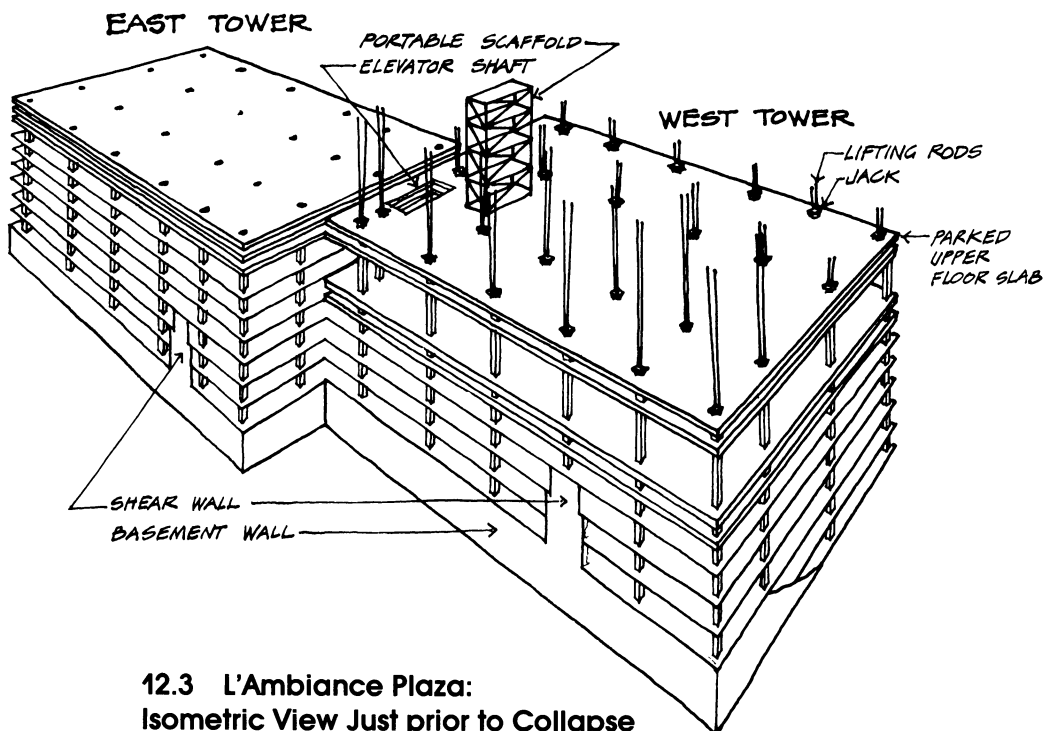
**12.3 L’Ambiance Plaza:
Isometric View Just prior to Collapse**

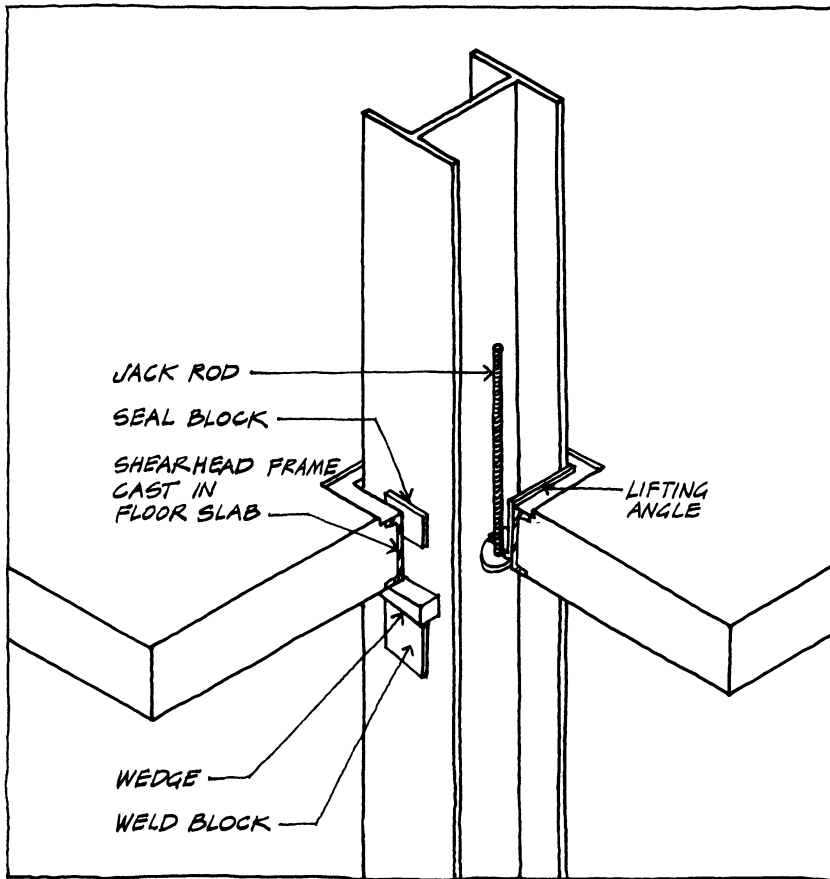
12.4 Typical Shearhead Arrangement

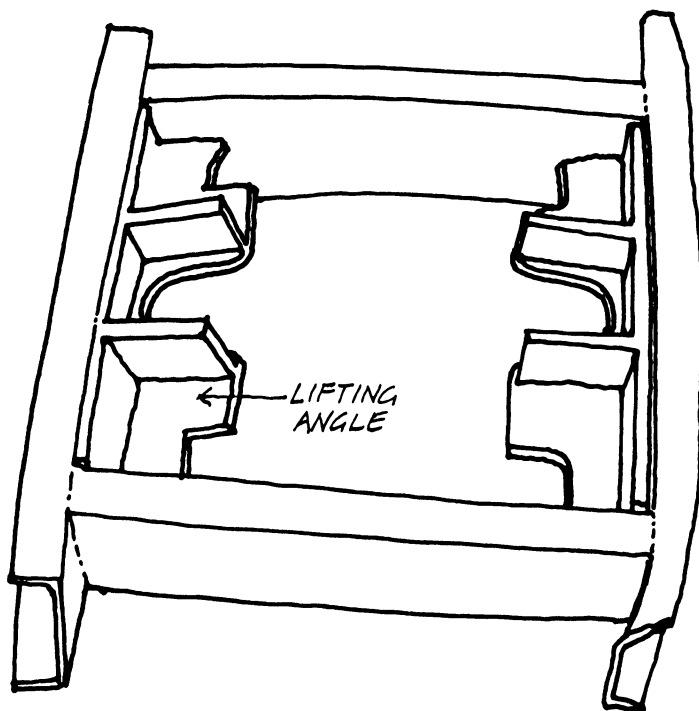
12.6 Failed Shearhead Showing Rotation of Lifting Angles

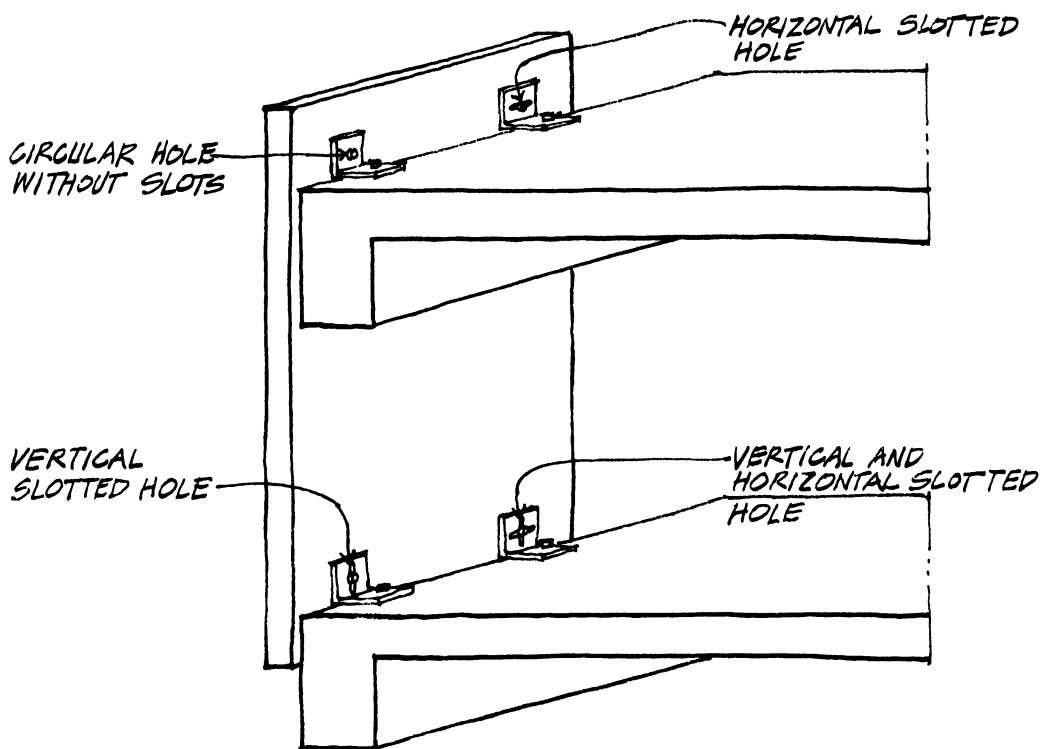
13.1 Attachment of Precast Panel

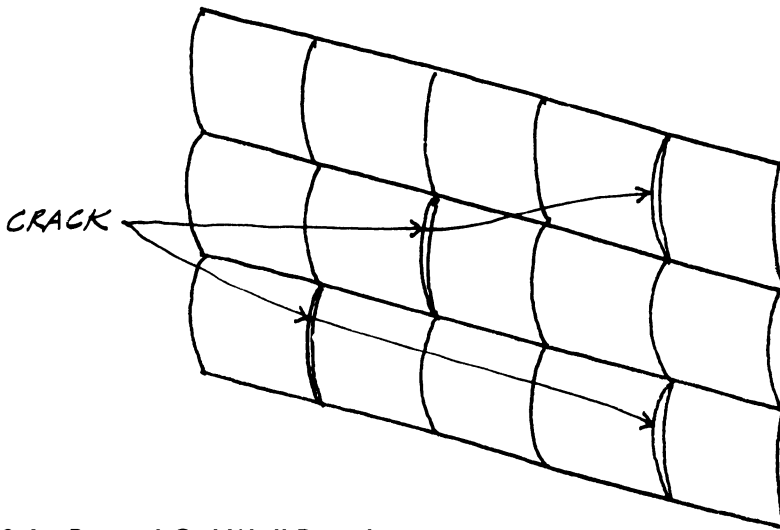
13.6 Bowed-Out Wall Panels

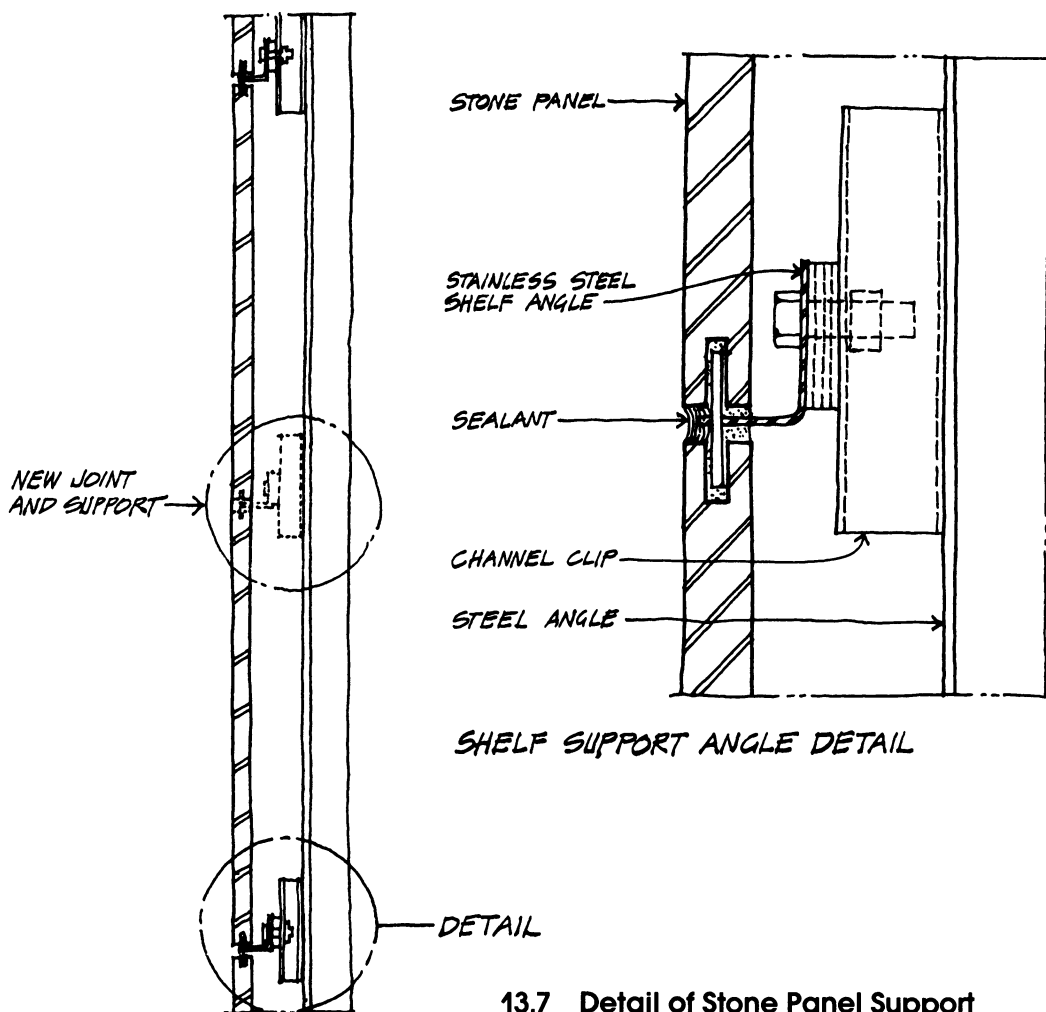
13.7 Detail of Stone Panel Support

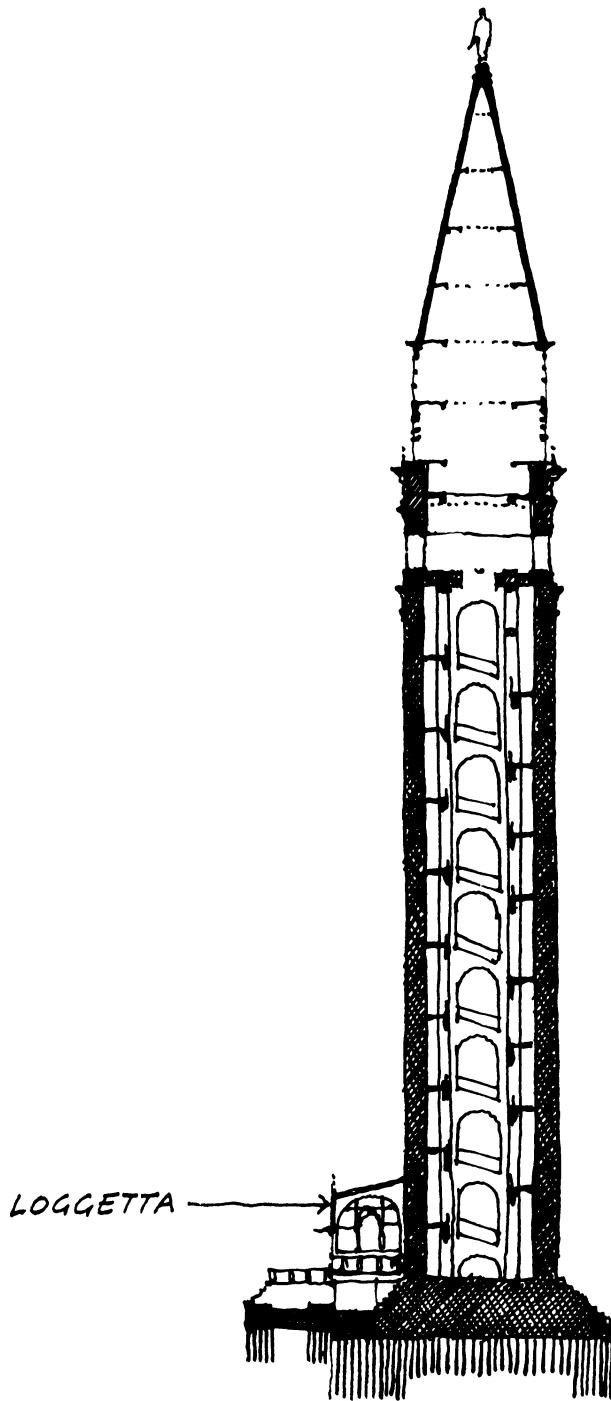
14.2 Section through Campanile of San Marco

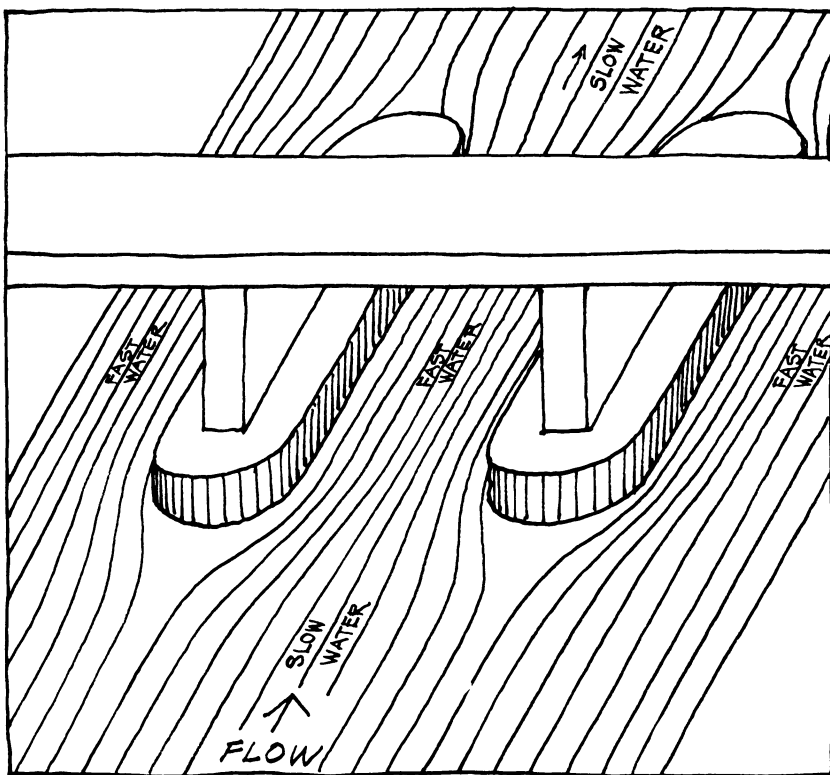
14.5 Flow of Water around Bridge Piers

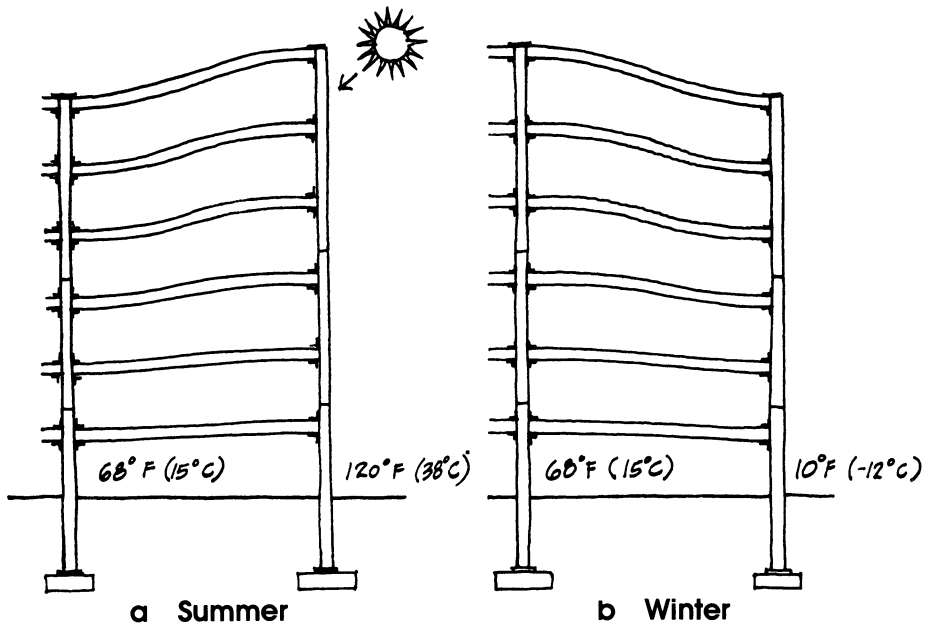
A3 Thermal Bending of Frame Beams in:

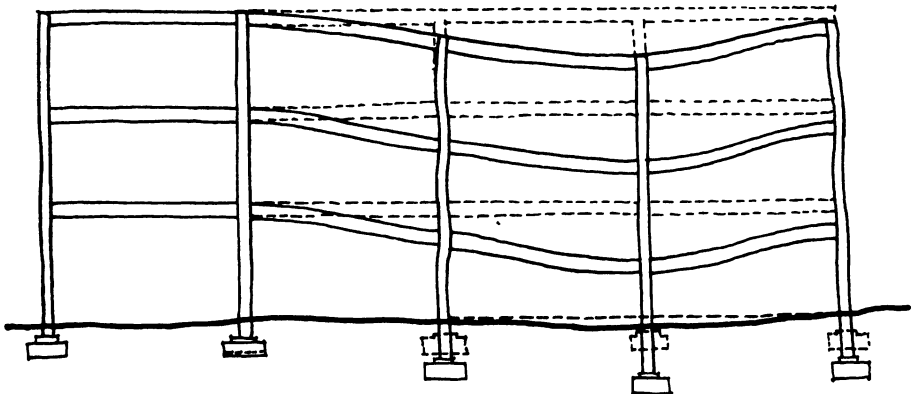
A4 Uneven Settlement of Building Foundation, Causing Bending of Beams

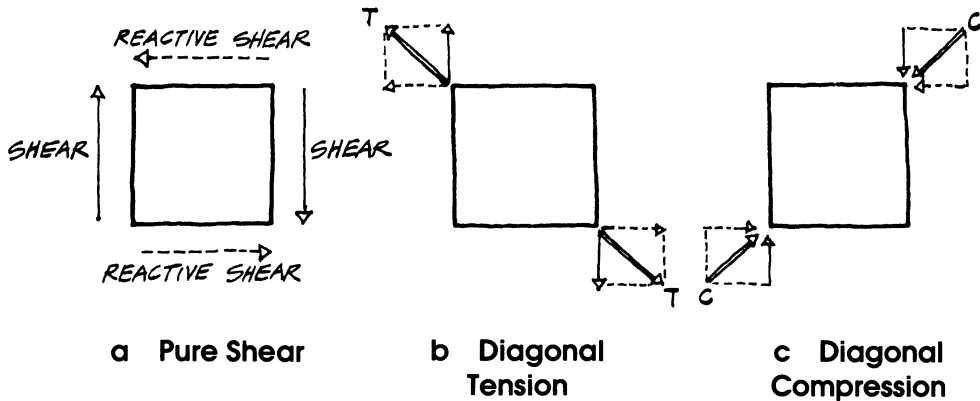
D12 Shear Equivalent to Tension and Compression

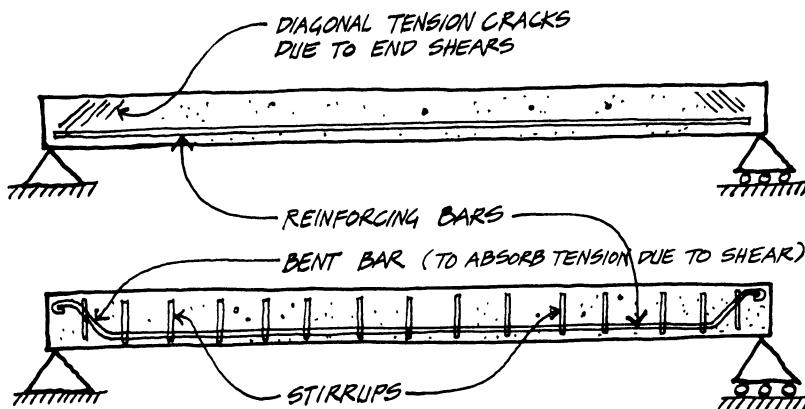
D13b Reinforcing to Resist Shear in Concrete Beam

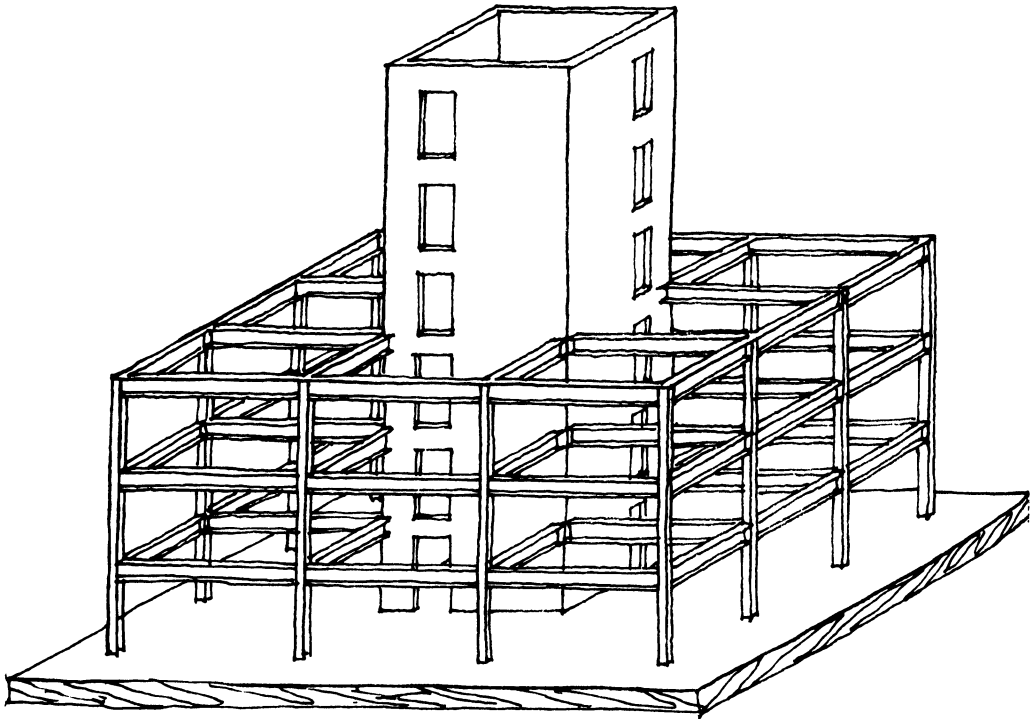
D24 Steel Frame with Concrete Core

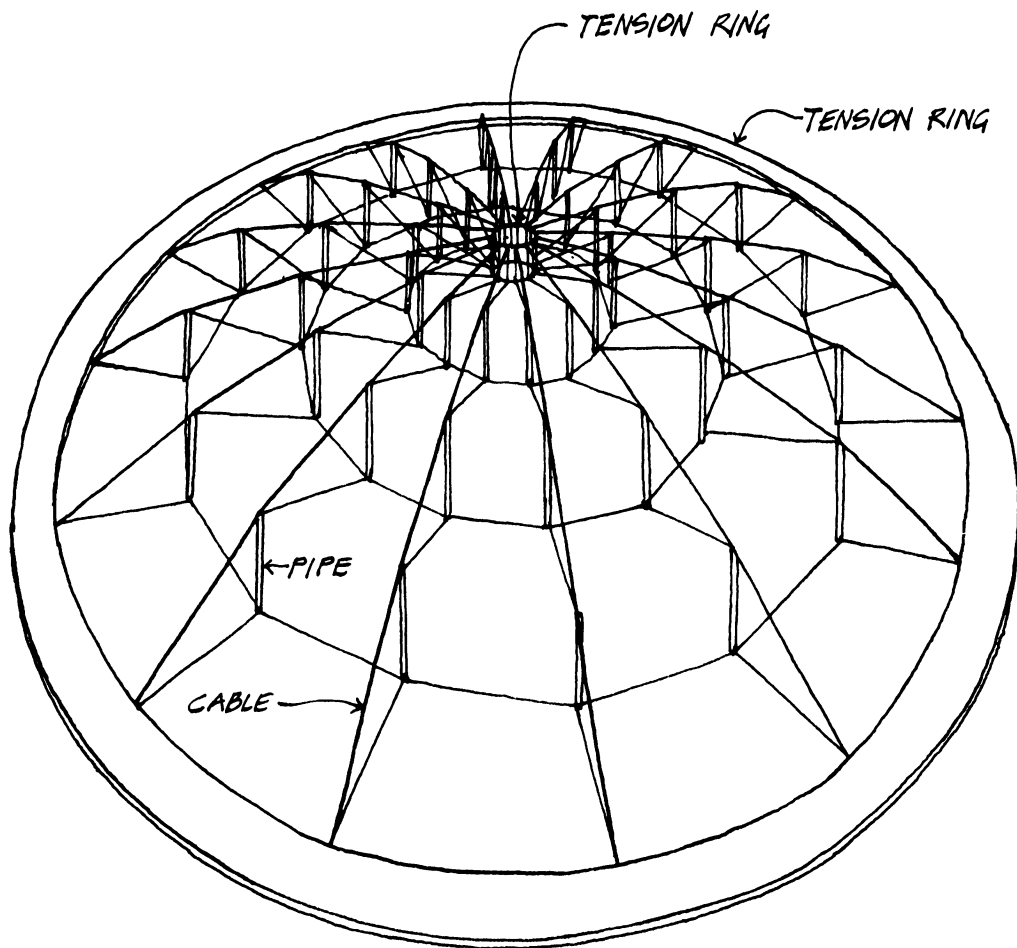
D34 Tensegrity Roof of Suncoast Dome, St. Petersburg, Florida
